# ADAPTIVE REUSE & REHABILITATION PLAN

## The Prescott Building Lancaster, Massachusetts

January 2012

## EXISTING CONDITIONS & RECOMMENDATIONS

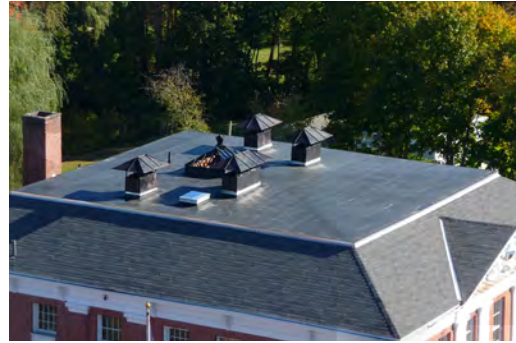
The roof was recently replaced during a project completed with the Massachusetts Preservation Projects Fund and is in excellent condition. The majority of the roof is a flat black membrane (epdm) installed in 2009 which is penetrated by four ventilators, a skylight, roof hatch, and two vents. The flashing at all of these features is in good condition. This roof can be anticipated to last another fifteen to twenty years.

The steeper sloped remainder of the roof is asphalt shingle, which likely was originally slate. The asphalt shingle roof is trimmed with aluminum flashings at the eaves, junction with the epdm roof, and in open valleys. These are all in good condition, with a life expectancy of fifteen to twenty more years.

Birds-eye view of roof.

- Maintain the existing roof in its present condition. Have the gutters cleaned at least once a year; plan on replacement with copper or galvanized steel.
- Plan to replace the corrugated metal downspouts with larger, round downspouts in a metal such as galvanized steel that will interact well with the existing aluminum gutters.

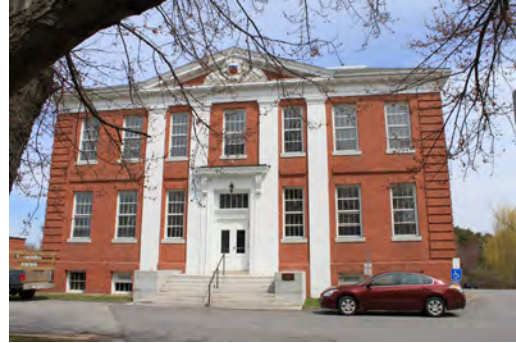
The West Elevation was previously preserved during a project completed with the Massachusetts Preservation Projects Fund and the results of this effort are apparent. Of the four elevations, the West is in the best condition. All of the windows were restored and all exterior woodwork was repainted as part of this project.

There are small regions in the brick work, mostly along the brick water table, where the mortar joints have eroded. At the front entrance there are long horizontal joints between stair treads that were previously filled with sealant which has deteriorated and pulled away from the stones.

West elevation from Thayer Memorial Drive.

- Restore basement window openings to double hung, four-over-four sash to match the historic windows.
- Spot repoint areas of failed mortar joints.
- Repoint all joints in brick water table.
- Remove failed sealant from joints between stair treads. Repoint joints with an appropriately colored and textured mortar to match adjacent pointed joints.

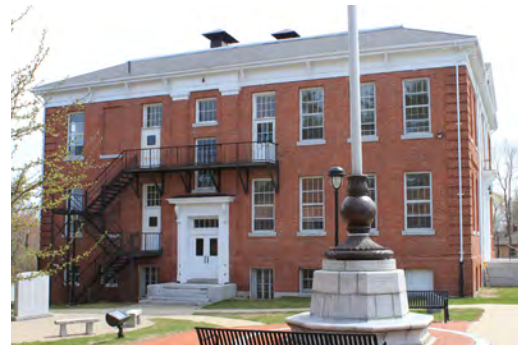
North elevation

Of the four elevations, the north elevation requires the most preservation work. Although in good condition from the entablature up, the windows on this facade are all in need of preservation. The aluminum storm windows are in poor condition. This elevation has a large steel fire escape that is beginning to rust extensively. The fire escape is an eye-sore on this facade, along with the three window openings which were converted to doors and the two window openings bricked in to accommodate the change. These features have marred the consistency of the openings on the facade and greatly altered its classical appearance.

The brick masonry and mortar joints are largely in good condition. However, mortar erosion is an issue at the water table and on the east end where a broken downspout has caused water to run over the brick quoins and walls, rapidly eroding the mortar joints. This downspout is still disconnected and in need of replacement. It should also be noted that the corrugated aluminum used for the downspouts and gutters is inconsistent with the building's history.

- Preserve all windows. Reglaze, repaint, weather strip, and replace storm windows.
- Restore basement window openings to double hung, four-over-four sash to match the historic windows.
- Remove steel fire escape and patch holes. Restore window openings and remove doors.
- Spot repoint areas of failed mortar joints.
- Repoint all joints in brick water table and area beneath the broken downspout.
- Reconstruct north staircase with a new foundation. This is an opportunity to address adding handicap access to this entrance.

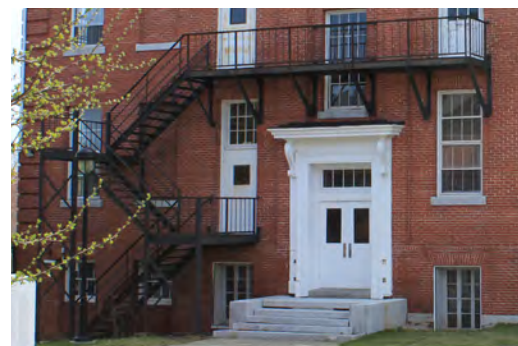
Steel fire escape and brackets are deteriorating. Three original window openings were converted to doors for access.

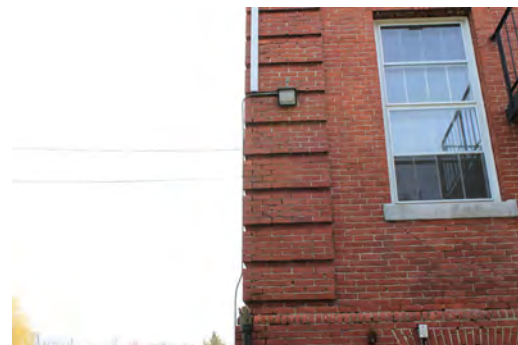
Broken downspout has caused severe deterioration to the mortar joints below

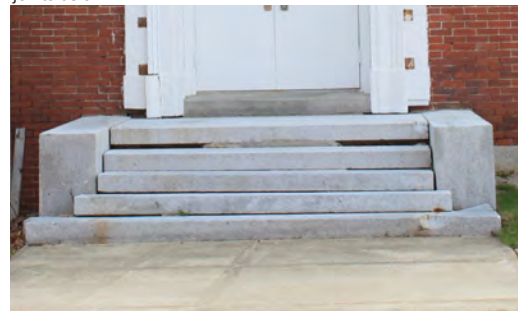
The granite stairway to the north entrance is in poor condition, with serious erosion at the mortar joints, dislodged stair treads, and a crumbling foundation beneath.

Shifted, separated granite steps at the north elevation.

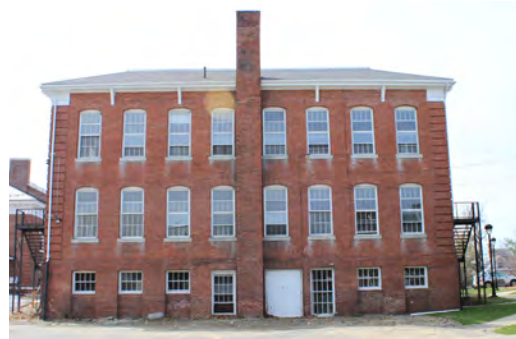
Beneath the window sills at each window, efflorescence, which is evidence of water infiltration, is seen on the bricks. This is likely caused by water entering the envelope at the juncture of the wood window frames and brick walls. The mortar joints of the water table on this elevation are also severely worn.

East elevation - note staining beneath windows

- Preserve all windows. Reglaze, repaint, weather strip, and replace storm windows.
- Restore basement window openings to double hung, four-over-four sash to match the historic windows.
- Replace double wood door.
- Spot repoint areas of failed mortar joints.
- Repoint all joints in brick water table and area beneath the broken downspout.

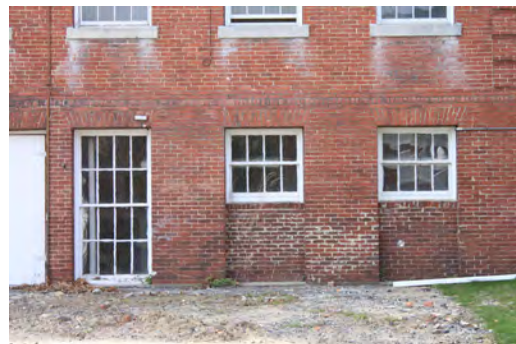
Rear elevation. Brick efflorescence, evidence of water infiltration, under the window lintels and poorly executed repointing at the basement level.

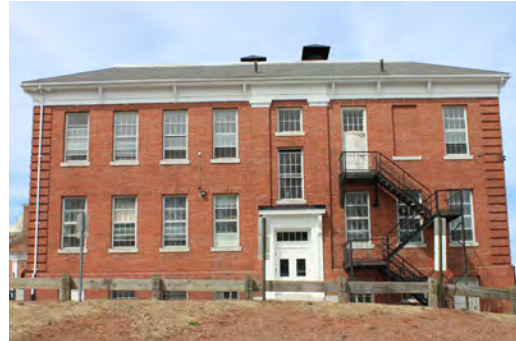
Failed mortar and open joints at the wall and watertable.

- Preserve all windows. Reglaze, repaint, weather strip, and replace storm windows.
- Restore basement window openings to double hung, four-over-four sash to match the historic windows.
- Remove steel fire escape and patch holes. Restore window openings and remove doors.
- Spot repoint areas of failed mortar joints.
- Repoint all joints in brick water table.
- Repoint granite staircase.
- Replace downspouts.

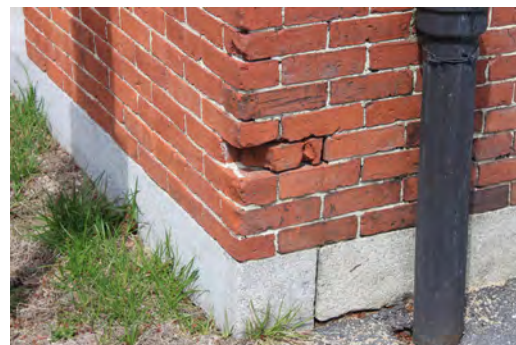
As was mentioned on the North Elevation, mortar failure is most severe at the northeast corner, where there is serious mortar loss and dislodged bricks have fallen to the ground. The deterioration here has been exacerbated by an adjacent downspout which broken and now empties down the brick face.

Dislodged bricks at the northeast corner.

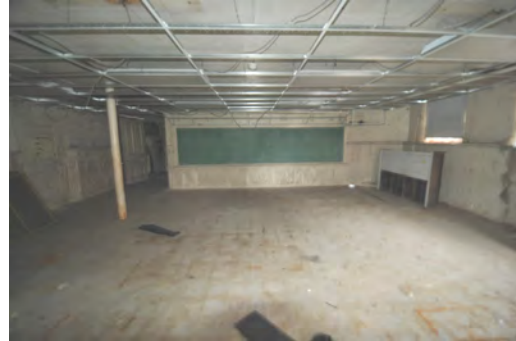
Former classroom in the basement level. Note dropped ceiling frame.

- Remove remaining dropped ceiling grids and lights. Install new ceiling.
- Scrape, prepare, and paint brick walls and wood wainscot.
- Abate asbestos tile and remove flooring to concrete slab.
- Install new mechanical, electrical, and fire protection systems.
- At minimum, install a dehumidification system for mold remediation.

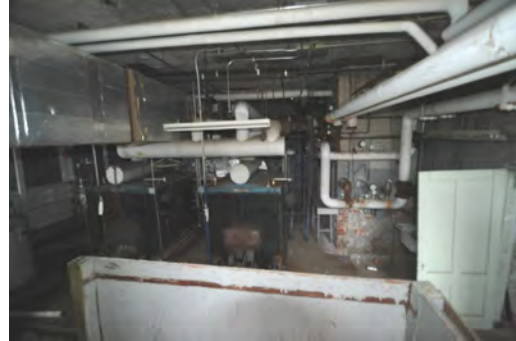
Mechanical room with asbestos laden piping and boilers.

- Repair and replace plaster ceiling as needed.
- Scrape, prepare, and paint brick walls.
- Abate asbestos tile in office.
- Install new mechanical, electrical, and fire protection systems.
- Remove and cap plumbing in rest rooms.
- Fill cracks and level existing concrete slab.

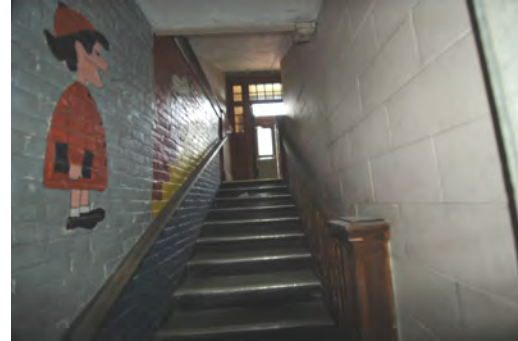
North staircase. The block wall on the left side of the image

- Repair and replace plaster ceiling and walls as needed.
- Scrape, prepare, and paint the brick walls at the basement level.
- Abate asbestos tile from the stair treads and landings.
- Install new mechanical, electrical, and fire protection systems.
- If required by the building code official, install an intermediate handrail. The current handrail is not code compliant.
- Modify the hardware at the existing doorways to provide code compliant egress doors.
- Reinforce existing stair framing. Return to plumb and level.

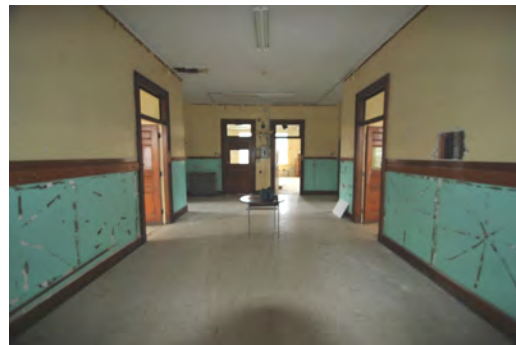
Second floor hall with damaged wainscot paneling.

- Repair plaster ceiling and walls as needed. Replace plaster beneath chair rail.
- Clean and refinish all clear-finished trim.
- Abate asbestos tile from the floor.
- Install new mechanical, electrical, and fire protection systems.

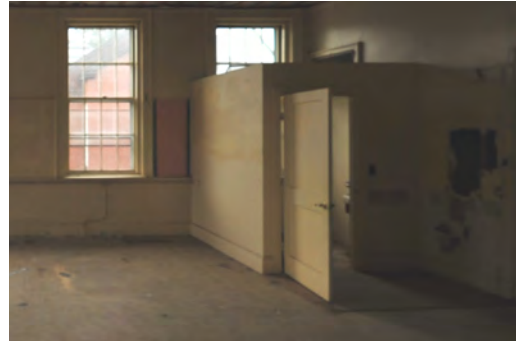
Toilet room inserted into classroom

- Remove first floor rest rooms and relocate to a more public location.
- Remove all plumbing from first floor rest rooms to basement.
- Remodel second floor rest rooms to provide two separate, fully accessible rest rooms, one for women and one for men.
