Site Observation Report

Site:	Lancaster U-Haul 90 Duval Road Lancaster, MA	Date of issue:	04/04/2022
Project #:	21-0091	Date of visit:	04/01/2022
Prepared By:	Michael J. Scott, PE Principal	Present:	Michael J. Scott, PE
To:	Mr. Jeff Vaine, U-Haul (via email)	Arrive:	3.00 PM
cc:	Lancaster Planning Board (via email) Lancaster Conservation Commission (via email) All County Paving (Site Contractor, Mr. Bob Foley, via email) 3 Oaks Environmental (Ms. MaryAnn DiPinto, via email)	Weather:	51°F mostly cloudy

Purpose of visit: rainfall of roughly 1 inch between evening of 3/31 and morning of 4/1. NPDES and Lancaster Conservation Commission & Planning Board require inspections after rainfall of 1/4 inch or greater. Rainfall on 3/31 and 4/1 based on data from weather station KMALEOMI72 (approximately 2 miles from the Site).

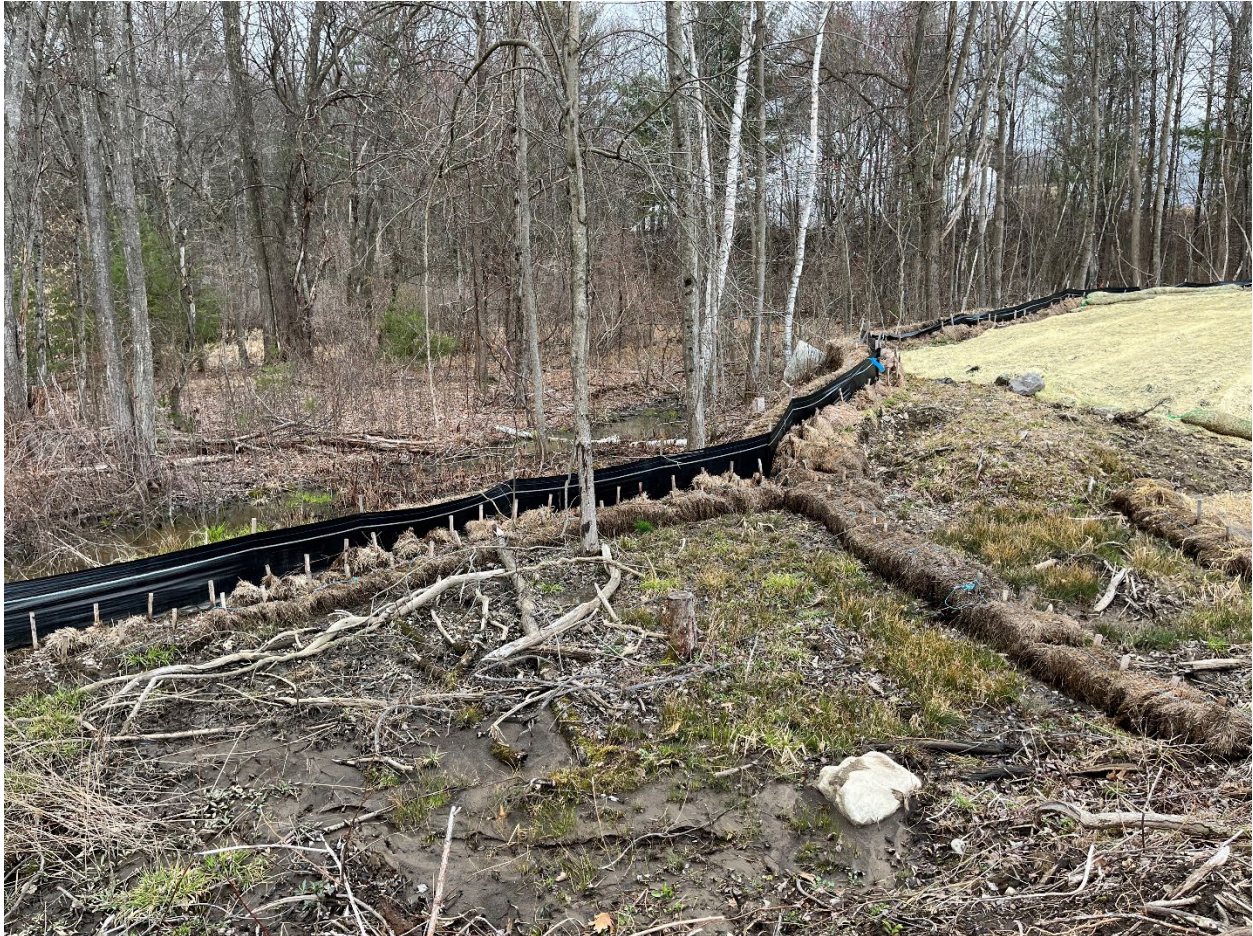
Photo 1 below	View of small wetland below W20-1 that has received some silt and sediment from above/right and the slope just at the bottom of the photo.
------------------	--

Items to be addressed: The erosion and siltation barriers at right above W20-1 need replacement. The toe of the slope at the bottom of the photo requires a line of siltation barrier above the small wetland area. The sediment and silt within the wetland area must be removed by hand from below W20-1 to the perimeter row of siltation barrier.

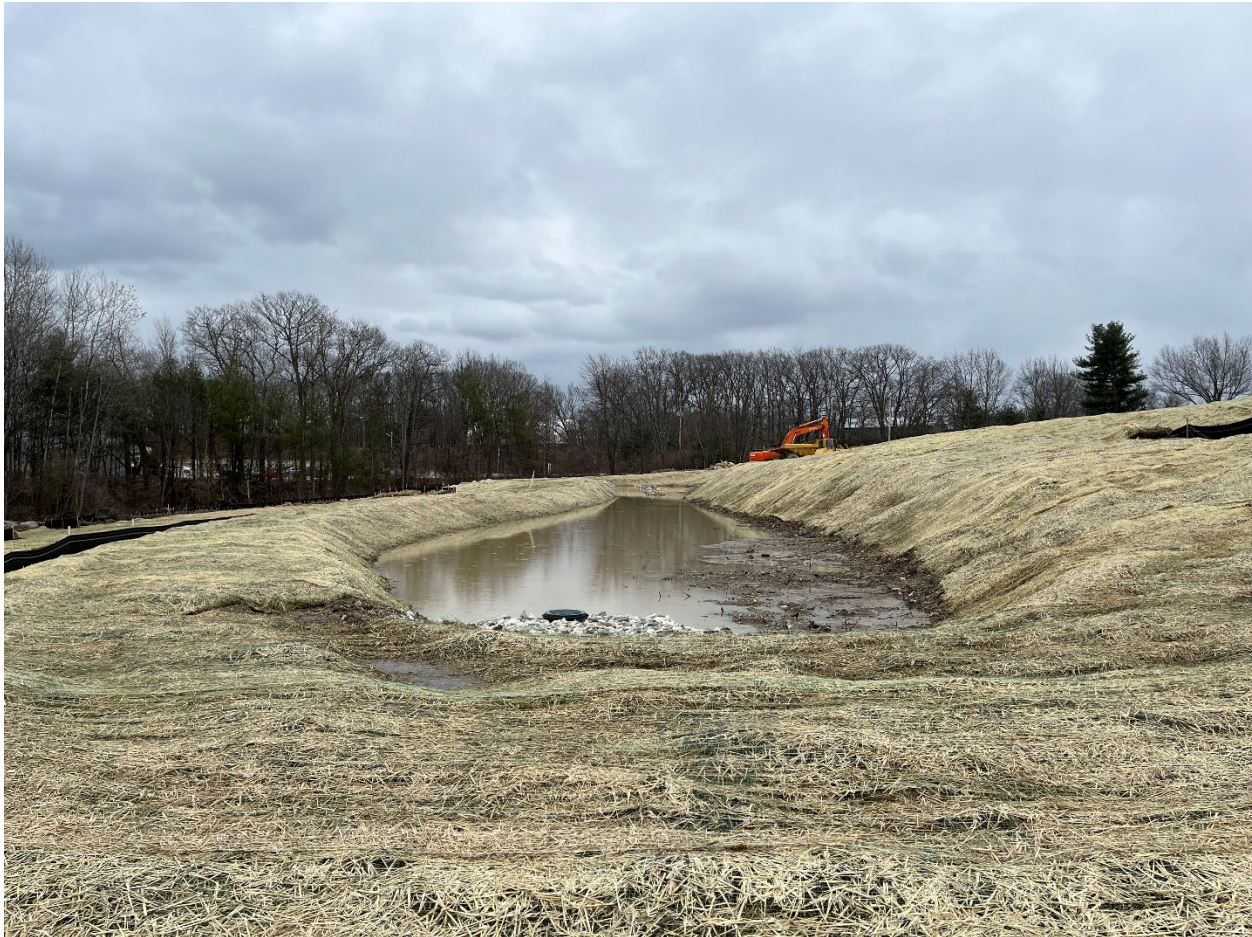
Photo 2 below	View of basin looking southeasterly. The basin had refilled some, with a trickle of flow from the near (northern) end drawn down as there was no flow in either outlet pipe.
------------------	--

Items to be addressed: The outlet spillway and stone berm meant to slow and filter the stormwater from the outlet pipe need to be extended (not shown in photo). A compost filter sock (ECB Type-2) should be added in front of the berm.
