## Site Inspection Report

**Re:** 90 Duval Road

**Date:** November 19, 2021

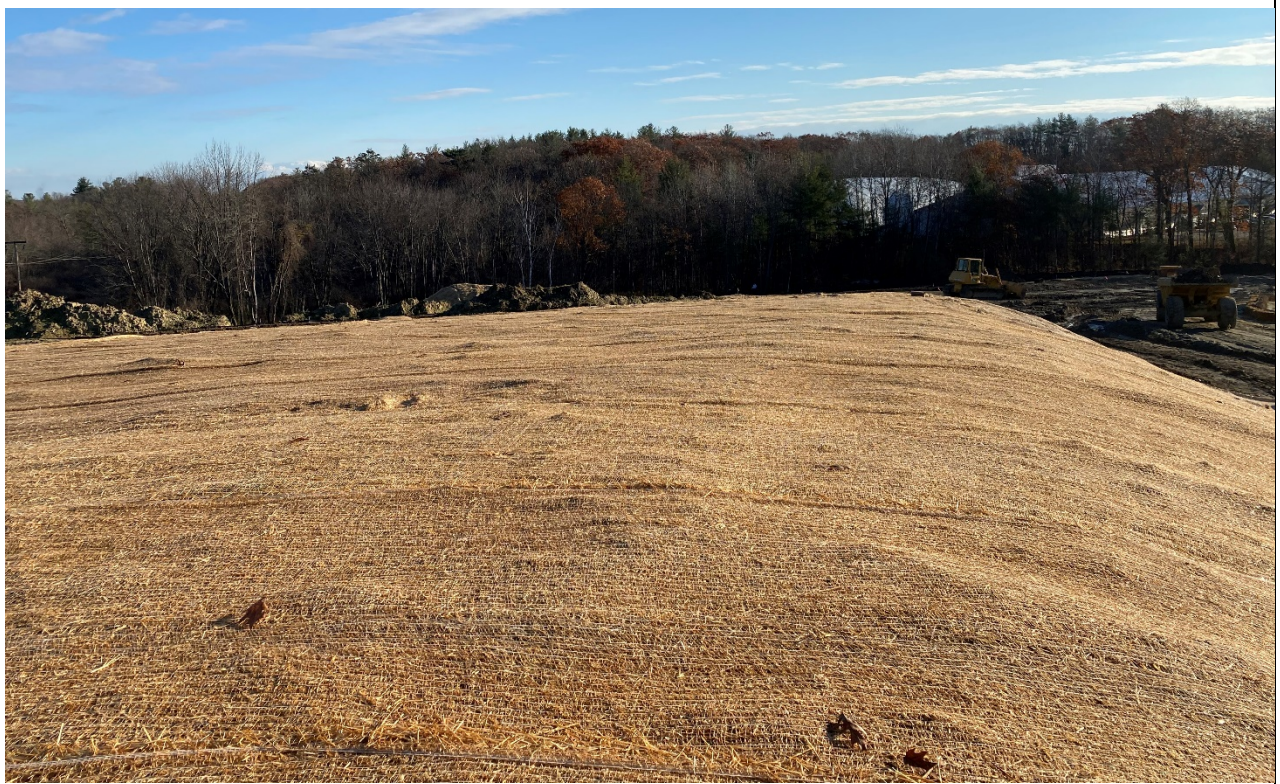
- **Erosion Control Blanket:** As shown in Photo 1, significant progress has been made over the past week with installation of erosion control blanket (ECB) in the western portion of the site. ECB has now been installed over most of the area to the west of the stormwater basin area that is being actively worked. CEI noted some relatively small areas where ECB has been installed that had uneven grading and poor soil contact. Mr. Vaine stated that these areas would be re-worked to ensure proper ground contact.

**Photo 1:** ECB has now been installed over most of the area to the west of the stormwater basin.

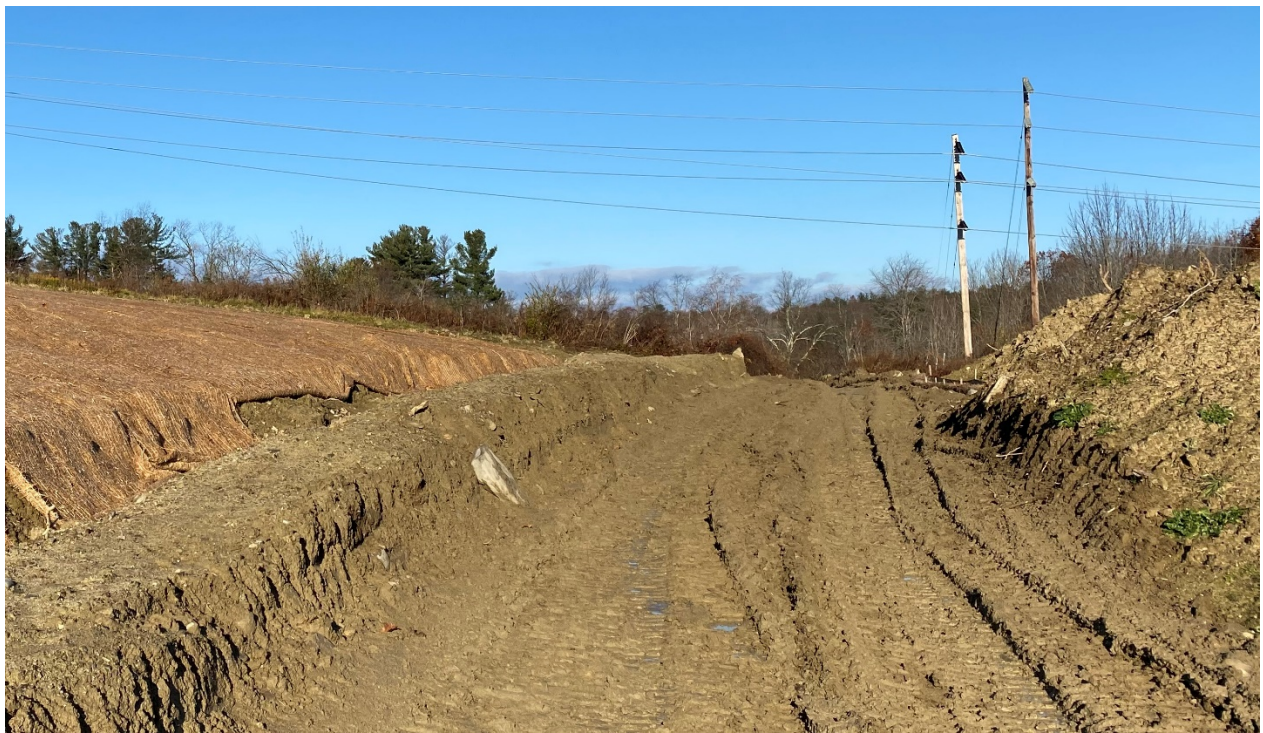
- **Temporary Haul Road:** As shown in Photo 2, a temporary haul road is in place between the area stabilized with ECB and the area of ongoing work in the vicinity of the stormwater basin. Mr. Vaine stated that this area would be graded, seeded, and stabilized with ECB after the haul road is no longer needed.

**Photo 2:** A temporary haul road is in place between the area stabilized with ECB and the area of ongoing work in the vicinity of the stormwater basin.

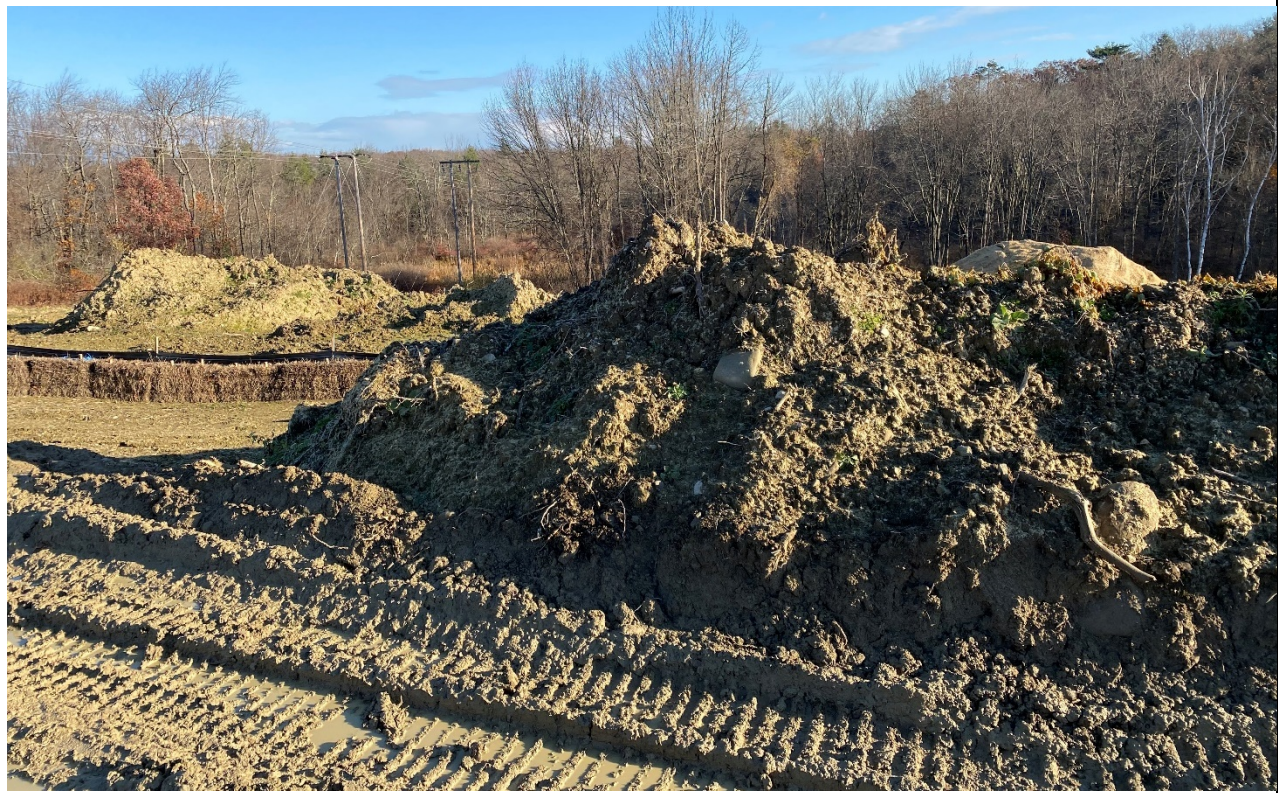
- **Soil Stockpiles:** As noted in the site inspection report from last week (11/12/2021) several loam stockpiles remain unstabilized (see Photo 3), Mr. Vaine stated that this loam will continue to be used over the next week for ongoing final construction/grading of the sediment basin area.

**Photo 3:** Several loam stockpiles remain unstabilized. Mr. Vaine stated that this loam will be actively used over the next week for ongoing final construction/grading of the sediment basin area.

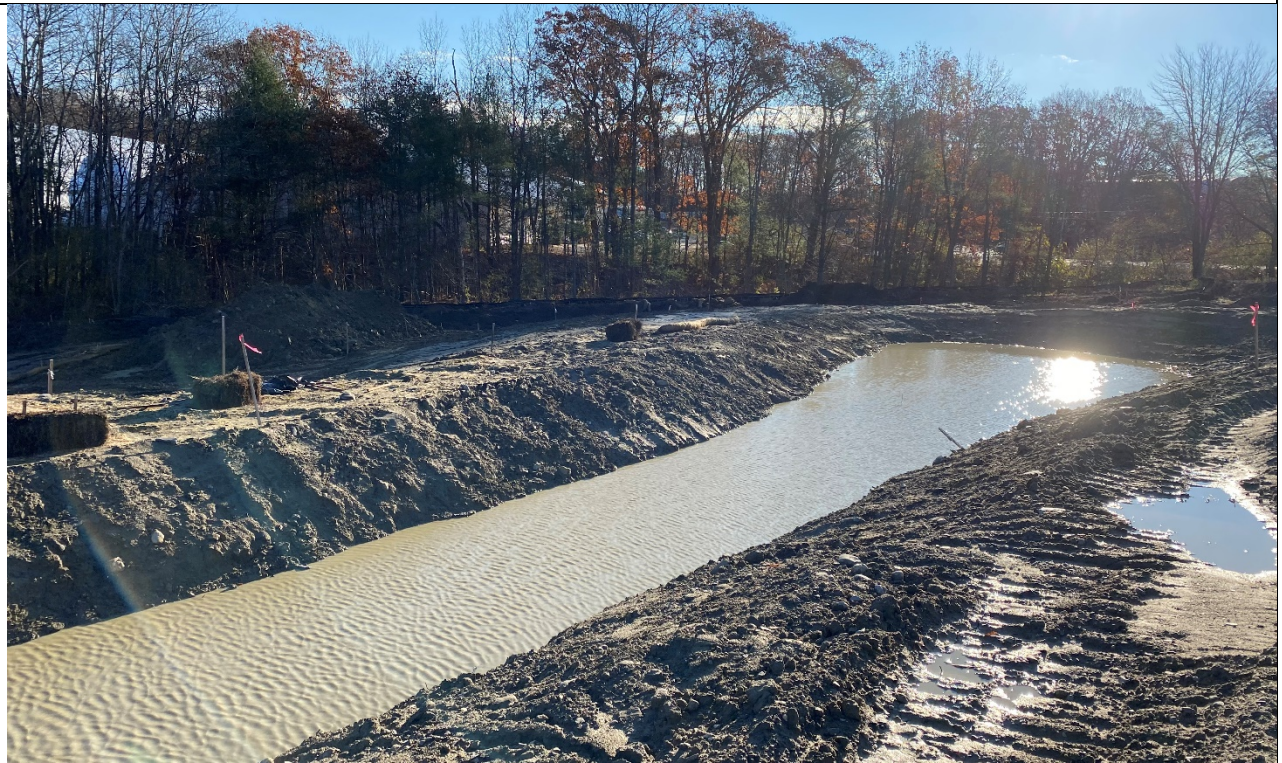
- **Temporary Sediment Basin:** The rough-graded temporary stormwater basin was observed holding water from the rainfall event during the preceding evening and early morning hours (Photo 4). The basin appeared to be performing as expected for this stage of construction and there was no indication that its confining berms had been compromised or overtopped by stormwater.

**Photo 4:** The rough-graded temporary stormwater basin was holding water from recent rainfall. The basin appeared to performing as expected, with no indication that its perimeter berms had been compromised or overtopped.

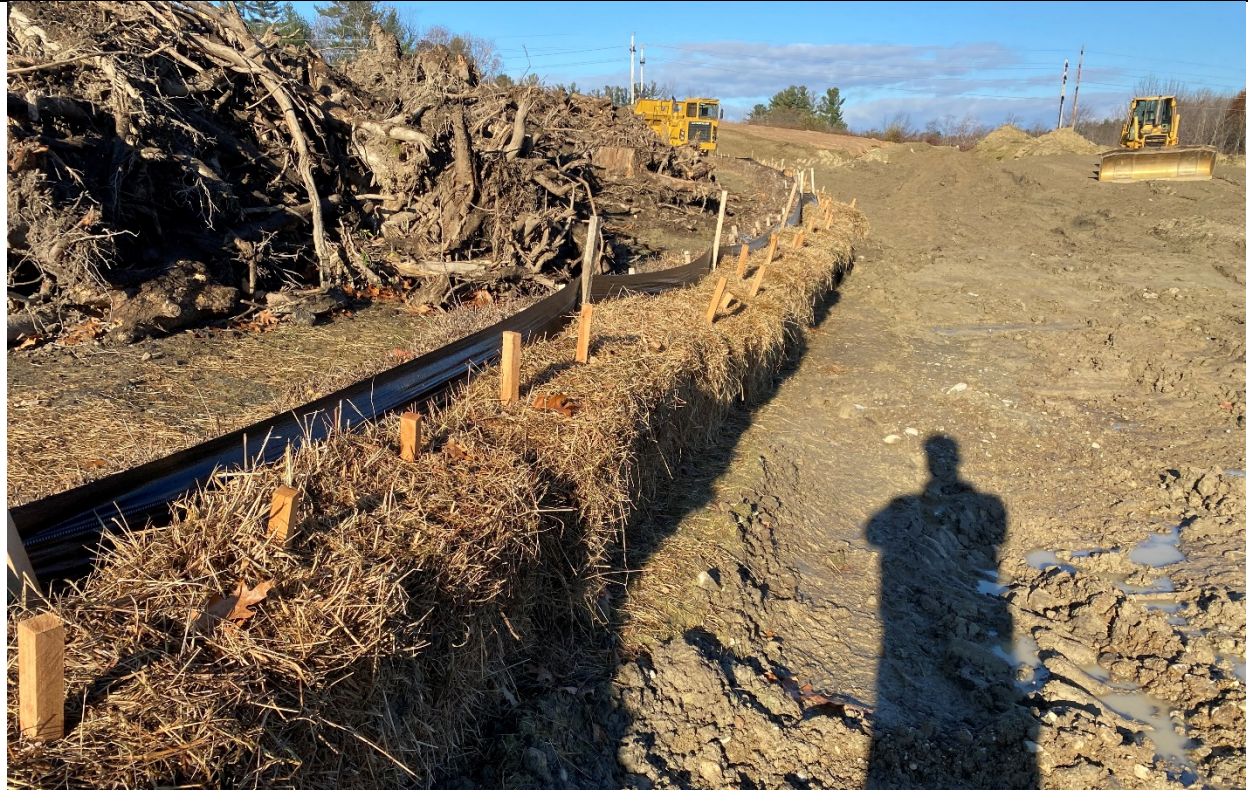
- **Silt Fence with Straw Bale:** Perimeter control silt fencing with straw bales were in good condition at the time of inspection. As shown in Photo 5, an additional row of straw bales has been properly installed on the downslope side of the silt fence within the interior of the site.

**Photo 5:** A row of straw bales has been properly installed on the downslope side of the silt fence within the interior of the site. Silt fence/straw bales along the downgradient (eastern) limit of disturbance were in good condition

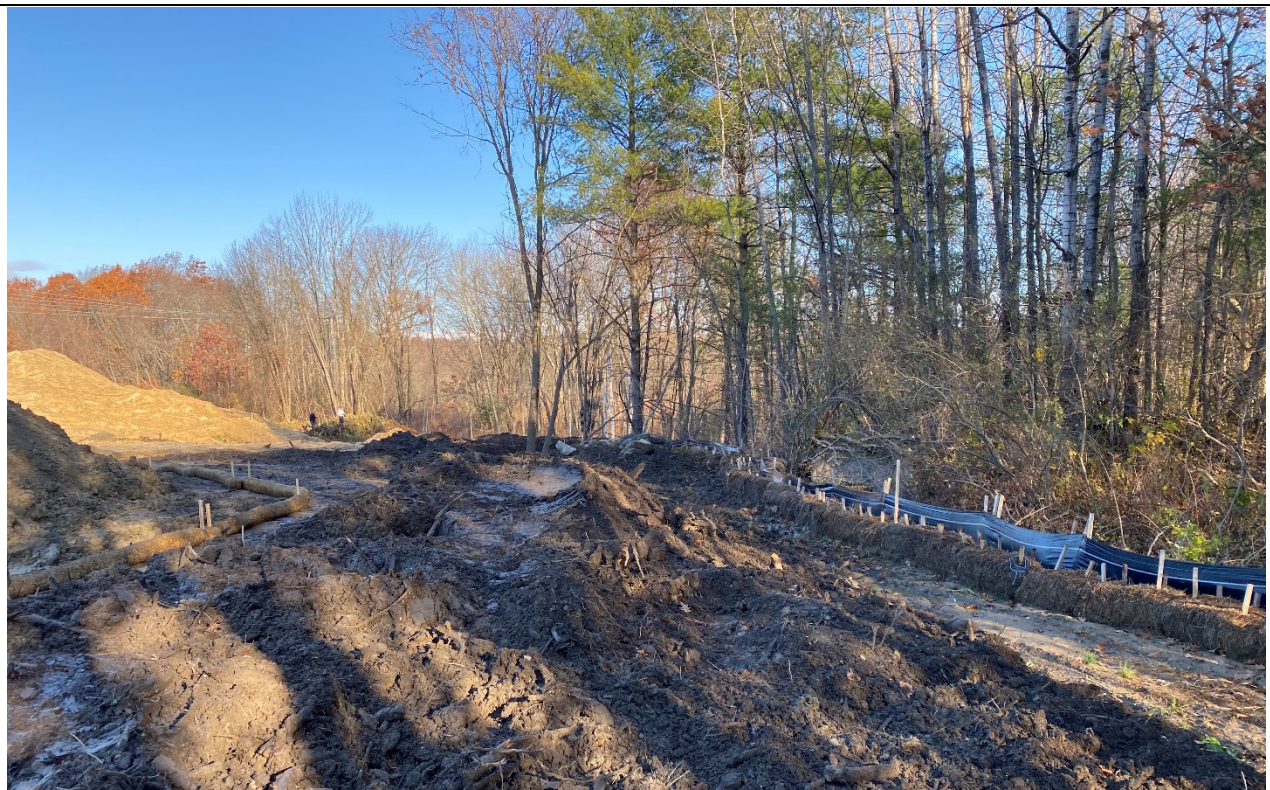
- **Removal of Earthen Berm/Stumps:** The 11/12/2021 inspection report noted that a berm of earthen material and stumps on the eastern side of the sediment basin was creating a temporary flow path towards wetland flag W20. As shown in Photo 6, there has been significant progress in removing this berm so that water from the stormwater basin can eventually discharge to its intended outlet. Photo 7 shows the temporary stockpile location of the stumps.

**Photo 6:** To the east of the stormwater basin, there has been significant progress in removing the berm of earthen material and stumps so that water from the basin can flow to its intended outlet.

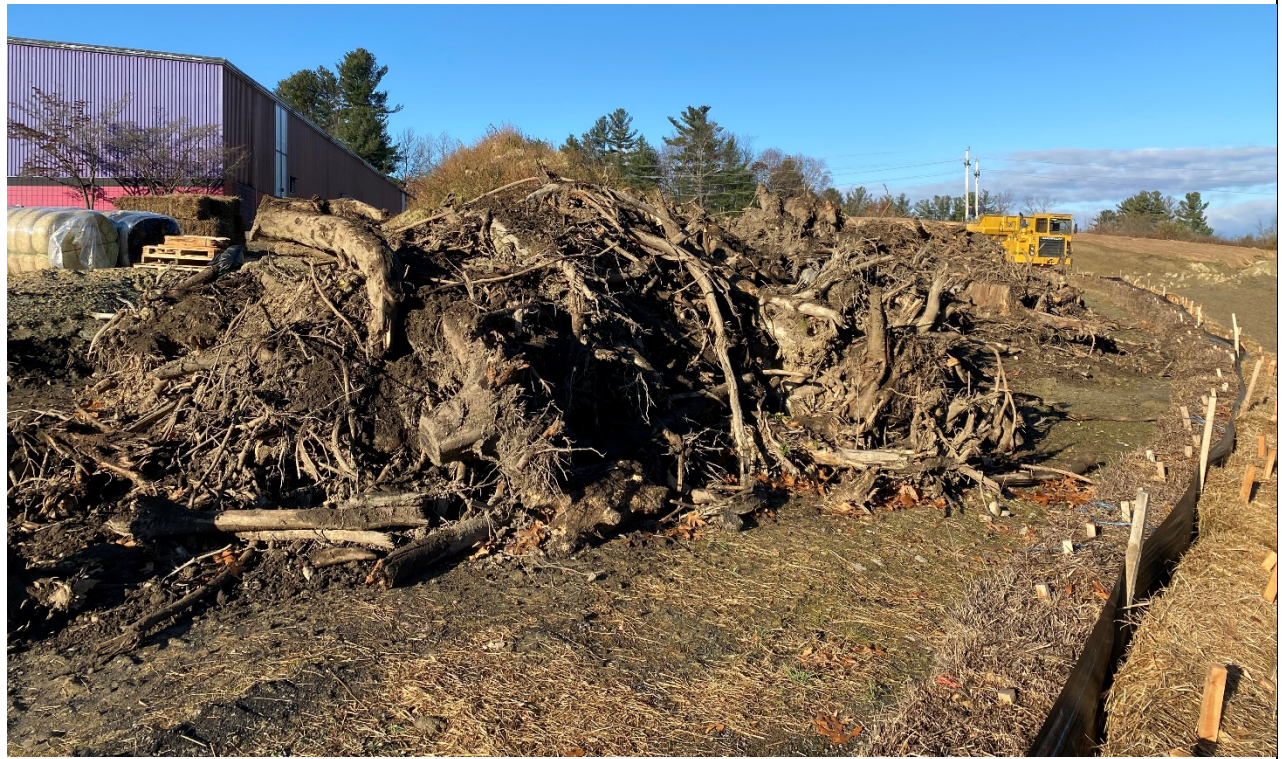
**Photo 7:** View of temporary stockpile of stumps from eastern perimeter of the site.

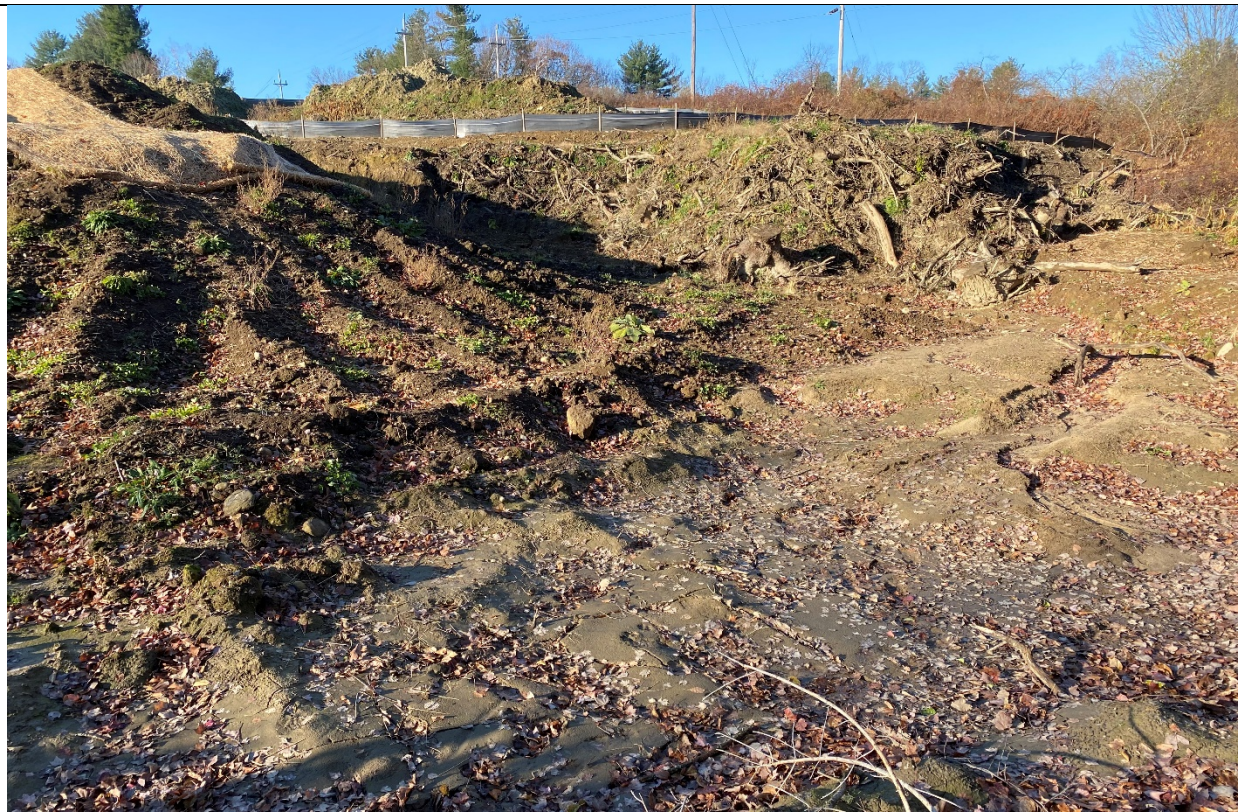
- **Unstabilized Area:** As shown in Photo 9, an unstabilized area along the northern boundary of the site is actively eroding, with an observed buildup of sediment that is being confined by an ungraded

**Photo 8:** An unstabilized area at the northern site perimeter is eroding, with sediment buildup confined by an ungraded berm. Mr. Vaine stated that this area would be graded and stabilized within 2-weeks.

earthen berm on its northeastern end. Although this area does not appear to pose an immediate risk of off-site discharge of sediment to wetlands (due to the berm), CEI recommends that it should be stabilized as soon as is feasible. Mr. Vaine stated that temporary stabilization by equipment tracking/terracing was not feasible in this location due to the presence of stumps and that this area would be graded and stabilized within a 2-week period.
