**TOWN OF LANCASTER  
COMMUNITY PRESERVATION ACT COMMITTEE  
PROJECT APPLICATION FORM – FISCAL YEAR 2023**

**CPA Project Name:** The Bulfinch Meetinghouse Portico Restoration Project

# Conditions Assessment Report First Church of Christ Unitarian

Lancaster, Massachusetts  
January 2005

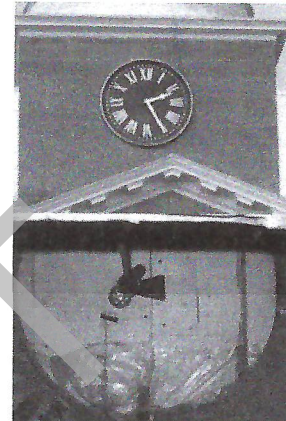
The clock was gilded and painted 1986, but the treatment has weathered. The wood clock face should be physically surveyed to test condition – it appears the lower quadrant is leaking and the church has installed plastic inside to keep water out of the cupola. After necessary wood repairs the clock face should be coated with smaltz, a durable mixture of dense paint and ground glass used on signs and clock faces since the 19<sup>th</sup> century. The hands and figures should be retouched with gold.

Weathered clock face (above).  
Plastic inside clock face (below).

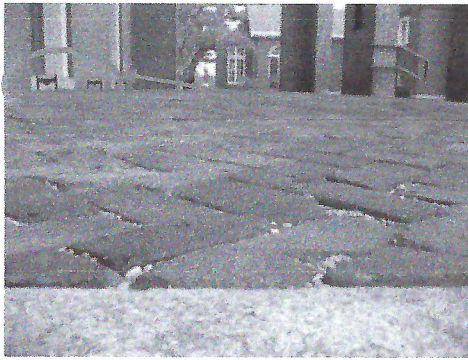
Uneven brick paving in Portico. Arrow indicates step up into Vestibule.

The portico brick paving is dry laid on a second layer of brick with sand between the joints and sand for bedding of the bricks. Bricks at the perimeter are settling and the entire surface is uneven. The brick presents a barrier to access. There is also a granite step up from the Portico into the Vestibule. This is also a barrier to access. The brick should be relaid to make it an even surface. A slope might be introduced as well to achieve access at the front doors to the Vestibule.

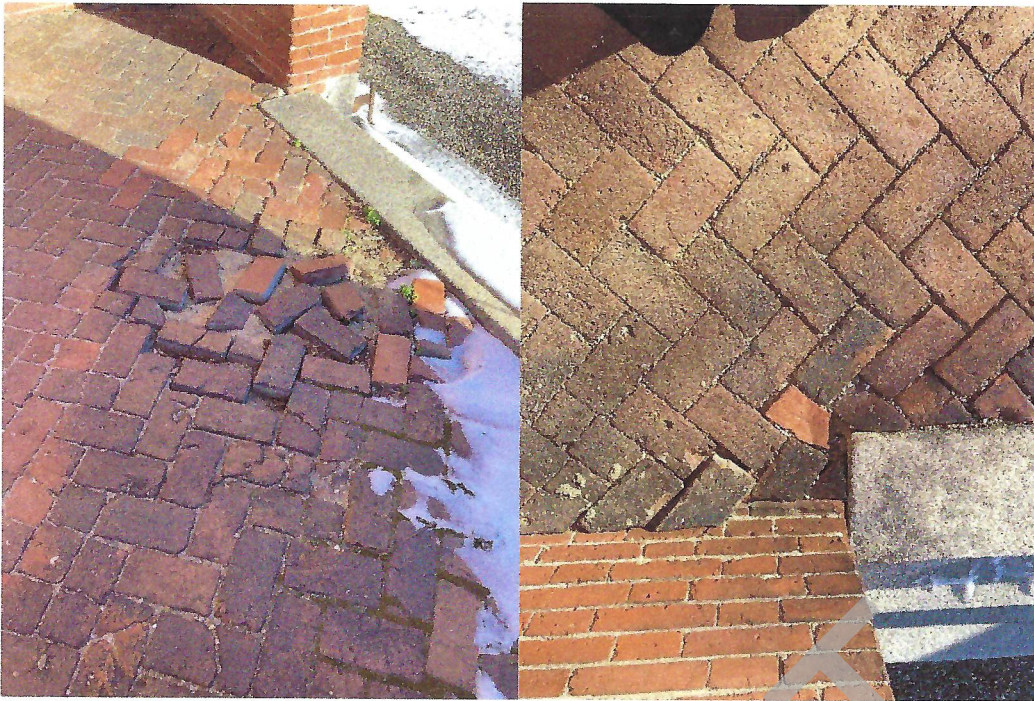
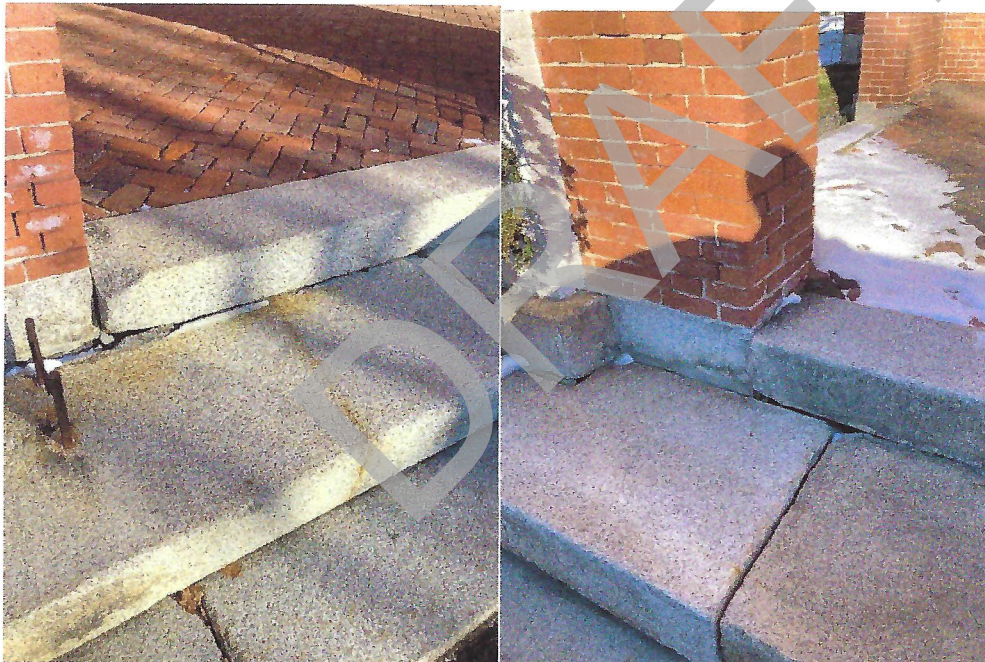
**Brick Flooring and Granite Steps**

I am writing on behalf of the Standing Committee of the First Church of Christ. We fully support the Bulfinch Fund in their efforts to restore the front and side portico floors of the Bulfinch Meetinghouse. The brick flooring has been uneven for a number of years now and represents a hazard for our members as well as for people visiting this historic landmark. We are excited to see the renewed effort to restore Lancaster's own National Historic Landmark.
