June 15, 2011

#### RE: MA01561 Bartlet Pond Dam Rehabilitation Preliminary Dam Removal Feasibility Study Report Lancaster, Massachusetts (PARE Project No.:10177.01)

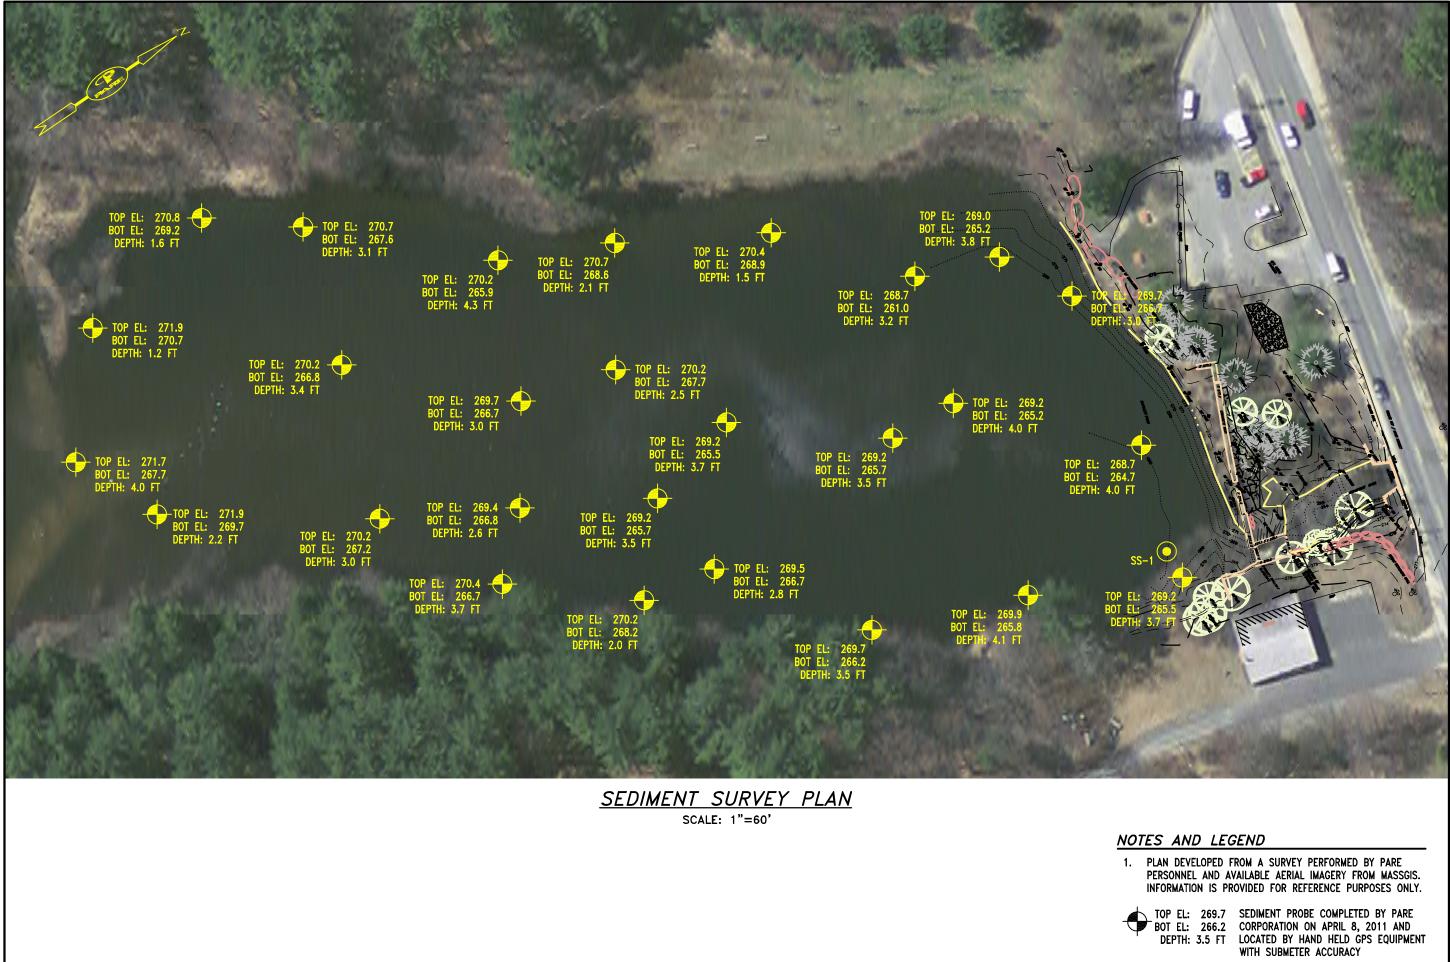
On April 8, 2011, PARE Corporation personnel completed a series of probes and soundings to evaluate the presence and depth of sediment deposits within the limits of the impoundment area. The probes and soundings were completed utilizing weight lines to determine the top of sediment elevation and steel rods driven through sediment deposits to refusal on the apparent natural pond bottom. Each exploration was located by hand held GPS instrumentation with sub meter accuracy. Location of each probe along with top of sediment, bottom of sediment, and thickness of sediment deposit are shown on Figure 2: Sediment Survey.

Based upon this program, sediment deposits averaging approximately 3.5-feet thick were typically observed throughout the entire impoundment area with sediment thickness of between 1 to 2 feet in areas at the upstream end of the pond and isolated areas nearer to the shoreline. Maximum sediment deposit thickness was measured near 4.3 feet and minimum thickness was measured near 1.2 feet. The sediment generally consisted of organic silts with more than 30% fines.

SEDIMENT SAMPLE LOCATION COLLECTED BY PARE ON APRIL 8, 2011

Given the observed sediment thickness, generalized cross sections of the impoundment were developed. Utilizing average end volume calculation methodology, a total volume of roughly 14,000 cubic yards of sediment is estimated to be present within the impoundment area.
