Vernal Pool Evaluation *for* Devens RFTA Hotel Range Reconfiguration

Environmental Division
USAG Fort Devens DPW
30 Quebec Street., Bldg. 666
Devens, MA 01434-4479

May 1, 2019

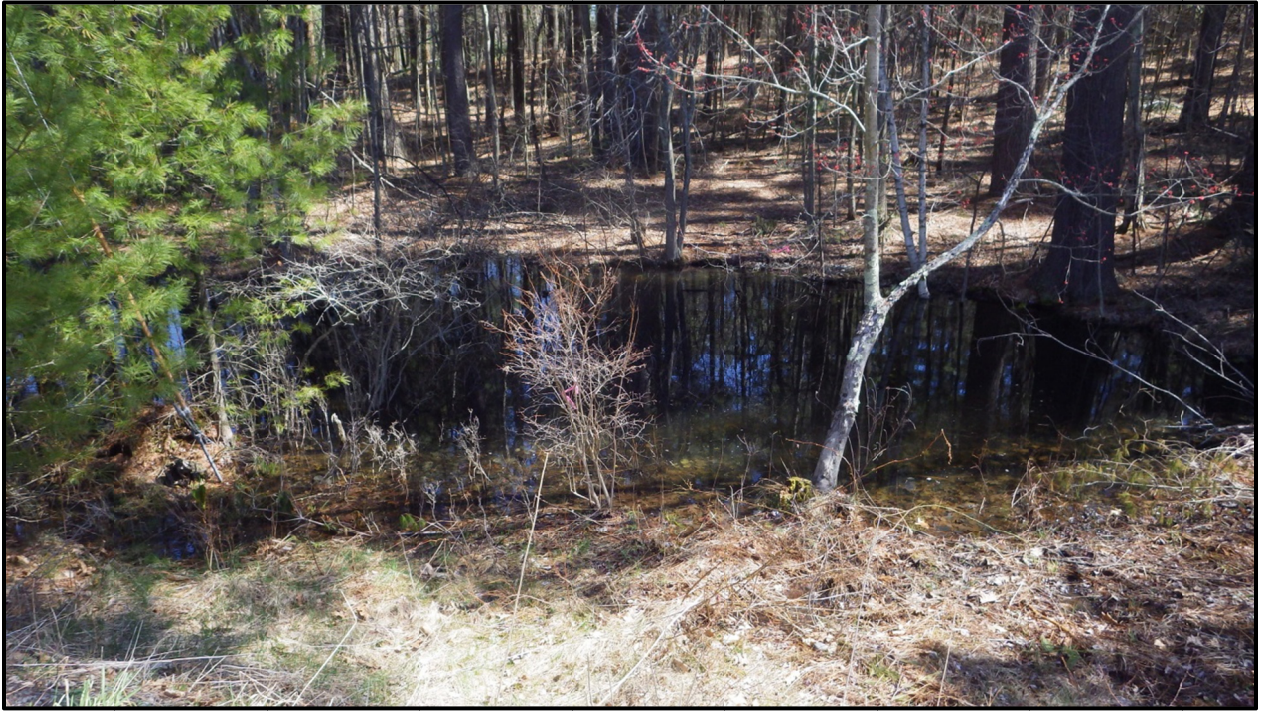
View of Wetland 4, an anthropogenic vernal pool adjacent to Hotel Range.

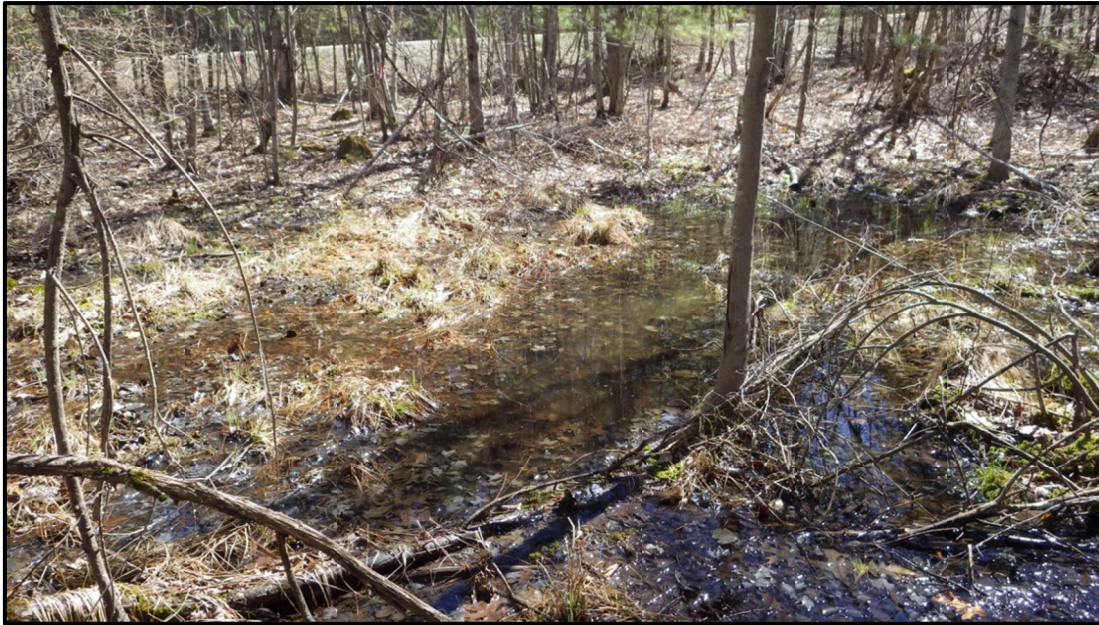
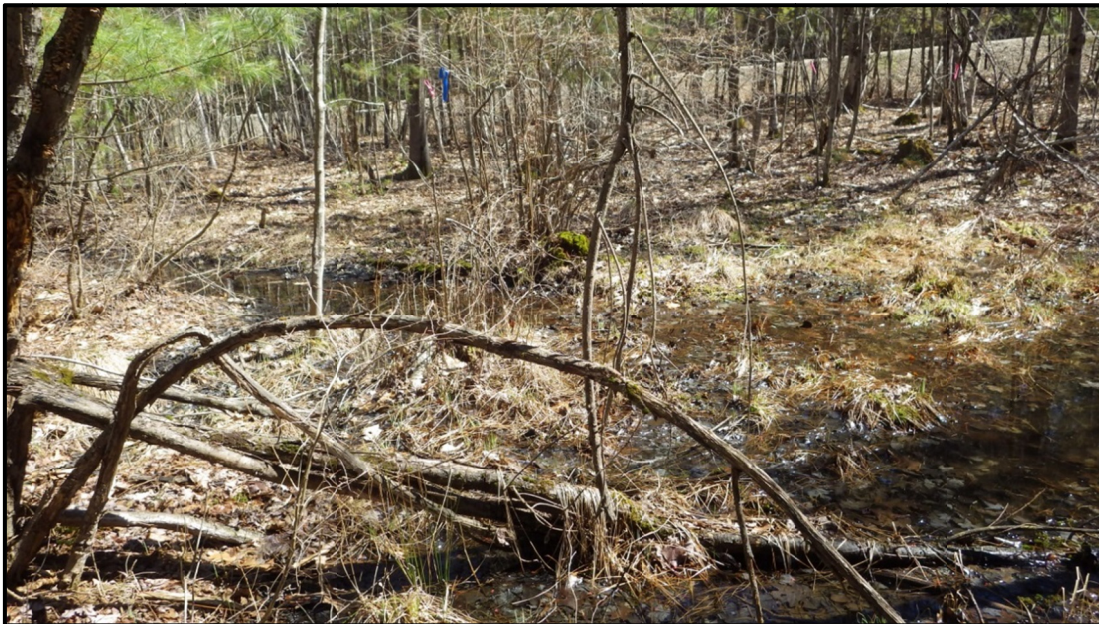
Wetland 1 is a shallow parabolic feature where groundwater discharges to the surface seasonally and discharges under the service road for Hotel Range to the north via a ditch and 12” culvert, ultimately to the BVW associated with Slate Rock Pond. The plant community there is predominantly herbaceous consisting of *Sphagnum* mosses, wool grass, tussock sedges and goldenrods, with sparse woody hydrophilic shrub species and sapling birch, red maple and white pine around its perimeter (see Photos 1, 2).

The hydroperiod of this feature is significantly influenced by plant transpiration as the vegetative community within and adjacent develops. The consistency of the benthic material suggests that the basin remains saturated through much of the season, but is unlikely to have persistent standing water after June of any typical year.

The maximum depth of this feature, established by the outlet invert at the road culvert is 14" with a mean depth estimated at 6 or fewer inches.

Figure 1. (above) View of **Wetland 1** to the NE with access road in background.
Figure 2. (below) View of **Wetland 1** showing outlet channel leading to culvert.

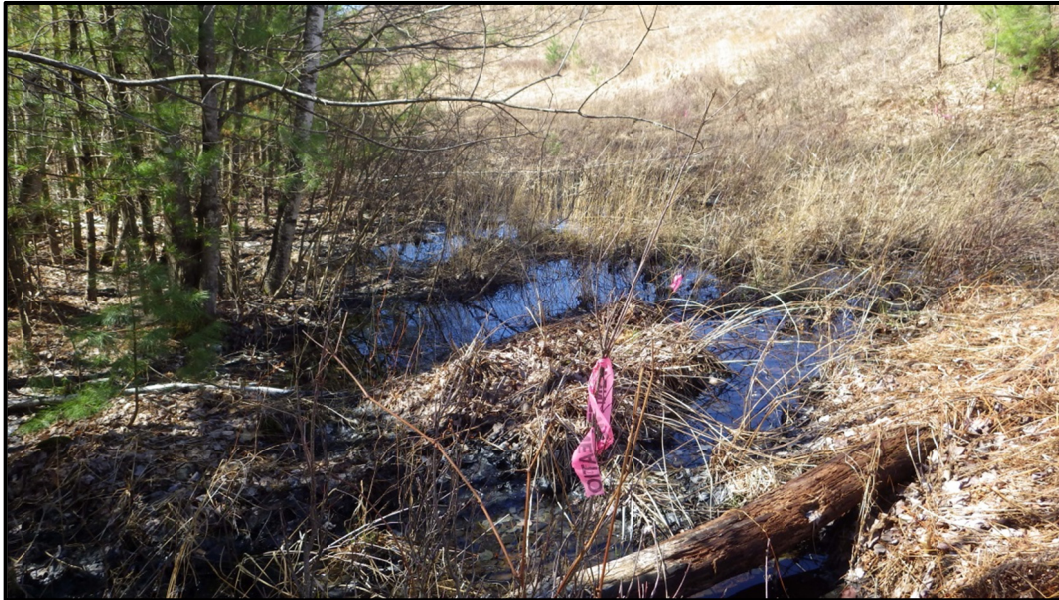
Wetland 2 is similarly an area of seasonal groundwater eruption with surface influence at the lower slope of a grassy field at the toe of a man made berm that drains by way of a channel to the outlet channel servicing Wetland 1. There are two minor basins, less than 200 square feet each, separated by some fill historic fill material upgradient of the main effluent channel.

Figure 3. (above) View to the SE of **Wetland 2**, swale habitat.

This feature appears less persistent than Wetland 1 and has blue-joint grass, cinnamon fern, steeplebush and sparse hydrophilic shrub occurrences (Photos 3, 4). The maximum depth of this feature is 8". Bottom substrate characteristics indicate it is without water for an extended part of the growing season.

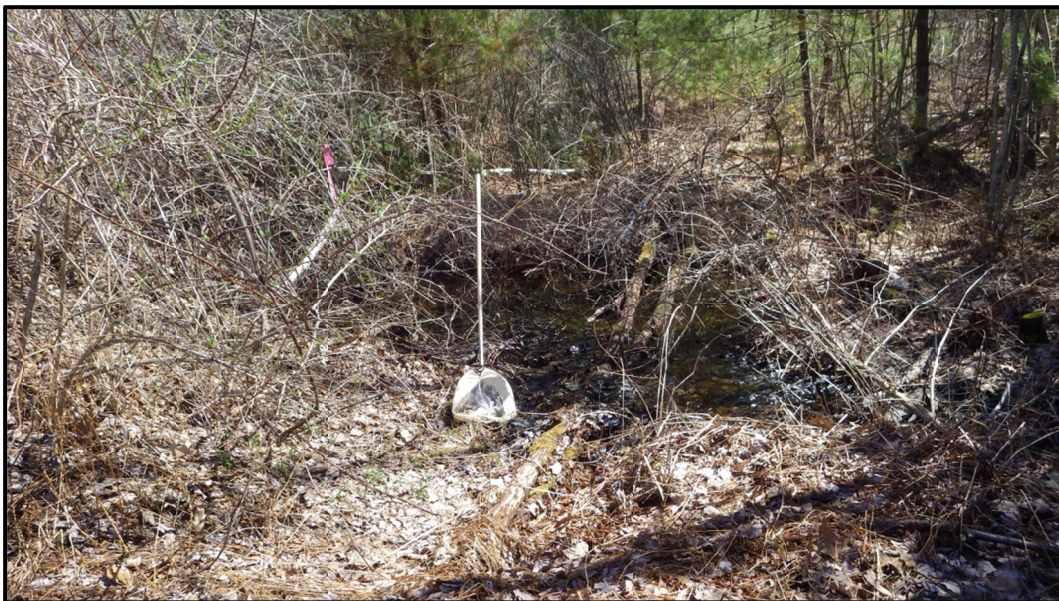
Figure 4. (below) View of lower basin of **Wetland 2**, with outlet channel partially obscured to the left).

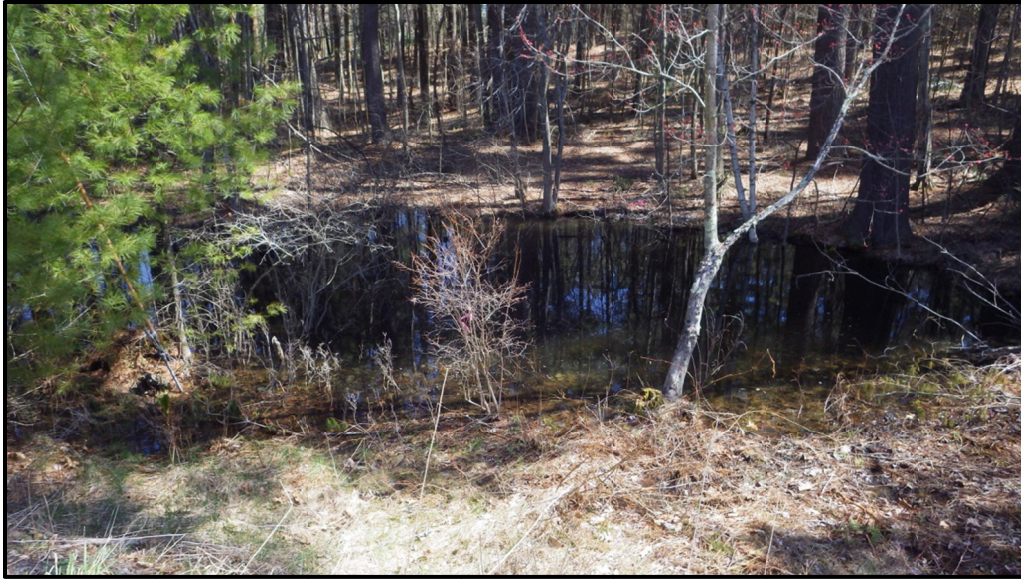
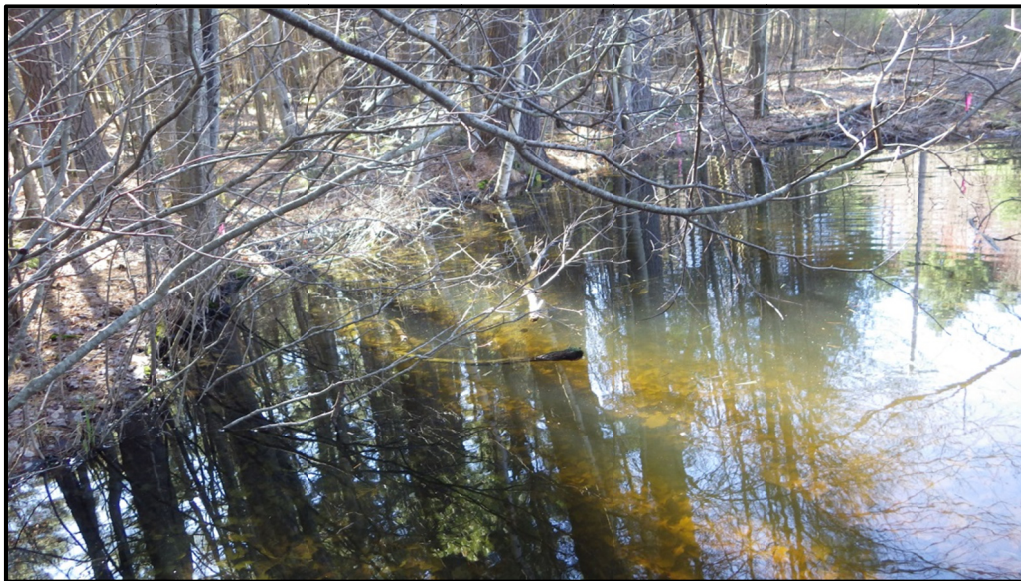
Figure 5. (above) View from access road NE to **Wetland 4** showing morning shaded conditions.
 Figure 6. (below) View to ESE across **Wetland 4** with location of submerged spotted salamander and wood frog eggs in the foreground.

Wetland 4 is an excavated, anthropogenic feature; probably a borrow pit used to build up the service road in an earlier iteration (> 30 years B.P.) of Hotel Range. Its outline is an ellipse with a long axis (NW- SE) of approximately 60 feet and a short axis of approximately 30 feet. The maximum depth of the basin is 38" and mean depth is estimated at greater than 2 feet.

Due to its positioning adjacent to the service road to the south and a stand of tall white pines to its southeast, east and northwest, this pool experiences limited insolation through much of the spring daylight period. With no significant surface or apparent groundwater inflow it probably remains frozen later than typical for vernal pools in the area and is probably not available for breeding for the normal or early waves of

amphibians. Nonetheless, it meets the MDFW criteria for certification based upon current year observations as described below (Photos 5, 6; Table 1).
