Re: 97 Woodland Meadow Drive

Subject: Implementation of Proposed Restoration Measures: Status Report

Site Photographs: 97 Woodland Meadow Drive – dates as noted

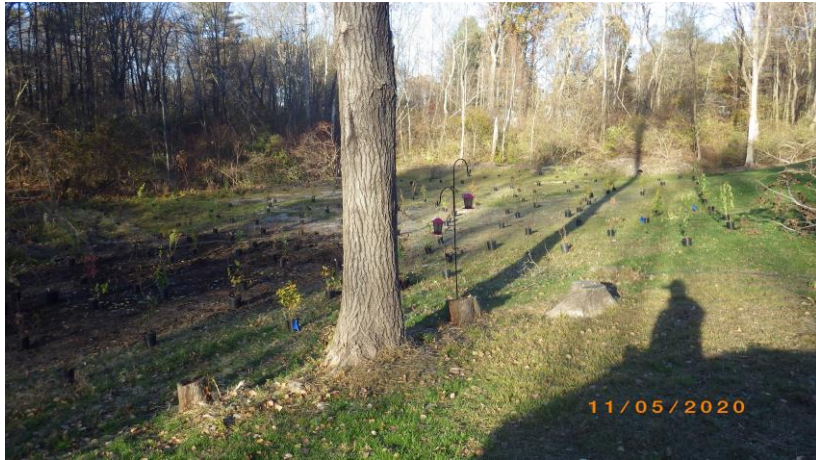
Plants laid out for planting

2. Planting: Plant stock was obtained from New England Wetland Plants, to ensure native species and cultivars. A copy of the plant stock invoice is attached. I personally supervised the layout of the proposed plants, to match the hydrology across the planting

area (e.g. winterberry were placed primarily in the lowest/ wettest portions). Attached are photographs of the area shortly before (plants in containers) and after planting. Note that many of the planted specimens are leafless due to autumn leaf drop. During my inspections I have observed scattered growth of native wetland herbaceous species, including sedges (Cyperaceae spp.) and skunk cabbage (*Symplocarpus foetidus*). It is my opinion that the native wetland hydrology of the affected Bordering Vegetated Wetland remains intact throughout the altered area;

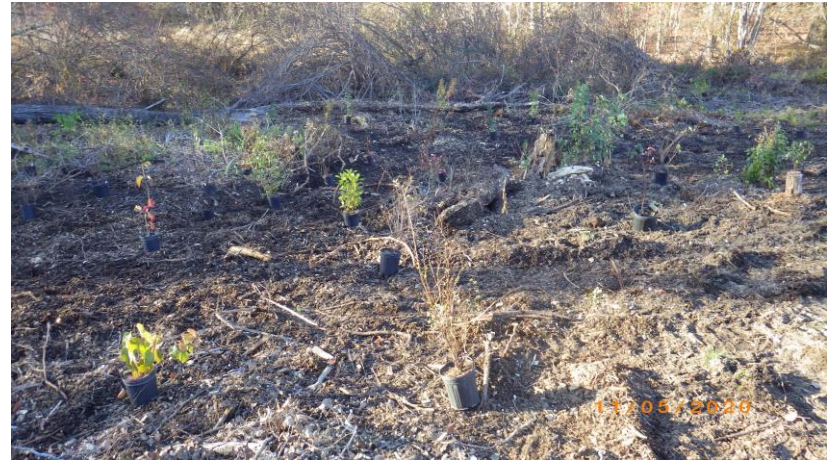
Plants laid out for planting

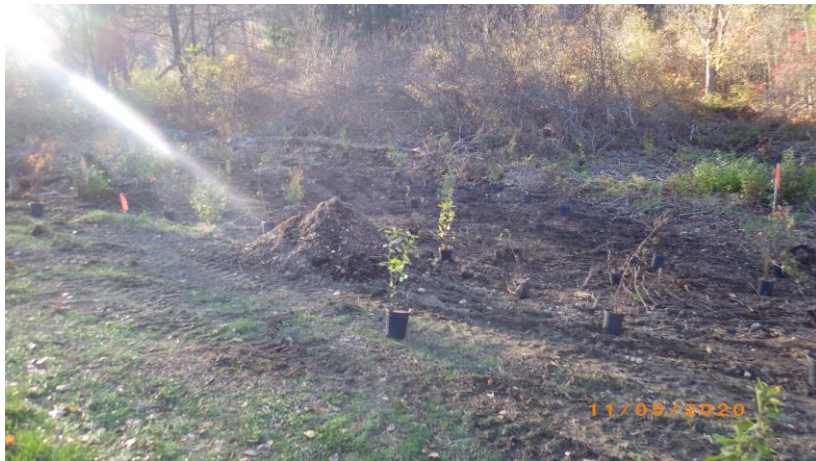
Plants laid out for planting
Remaining pile of wood chips for removal

1. Wood chip removal: Where wood chips were present in the BVW, the chips were collected with a mini tracked excavator with a grading bucket (no teeth) and workers using rakes and shovels, and placed into a small dump truck for reuse off site. I inspected the removal area and it is my opinion that the removal was consistent with my specification. As proposed, some remnant wood chips remain, but in my opinion the removal was sufficient to expose the vast majority of the native wetland topsoil, and allow for growth of planted and remnant wetland vegetation, but not overly aggressive to the point that it would eliminate any remnant wetland vegetation that may re-sprout in the spring.

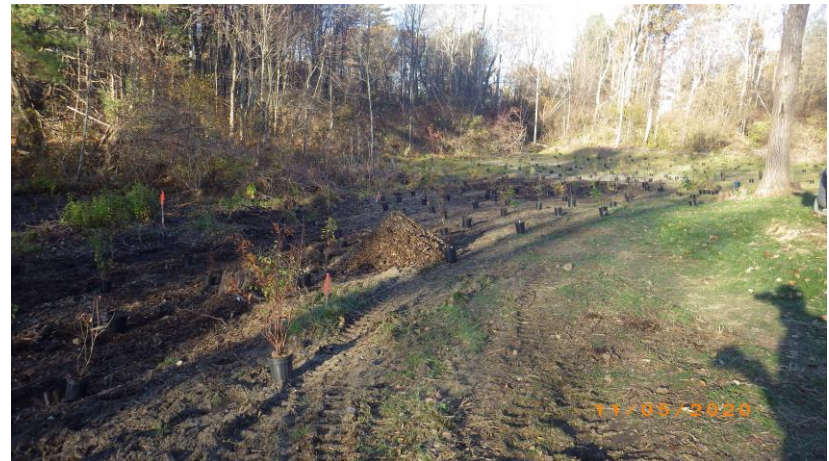
Plants laid out for planting

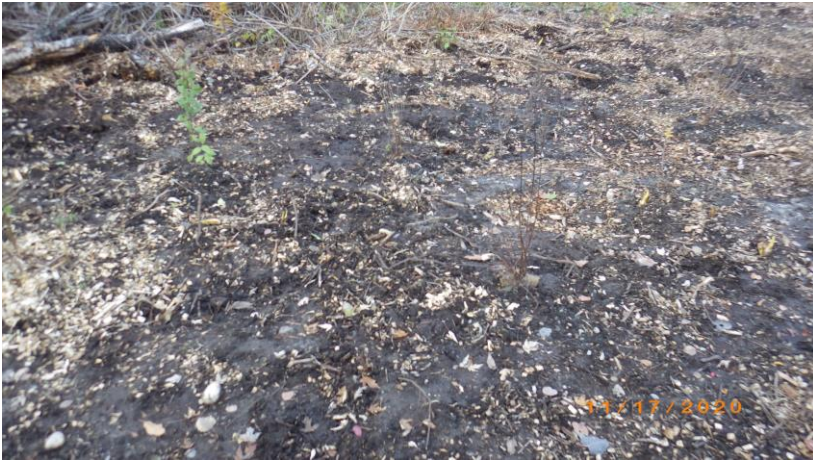
Typical Wood chip removal area after planting

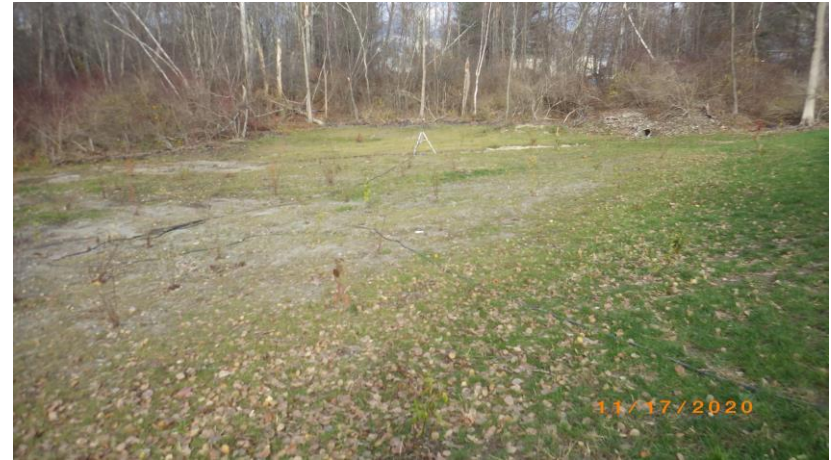
Eastern portion of restoration area after planting

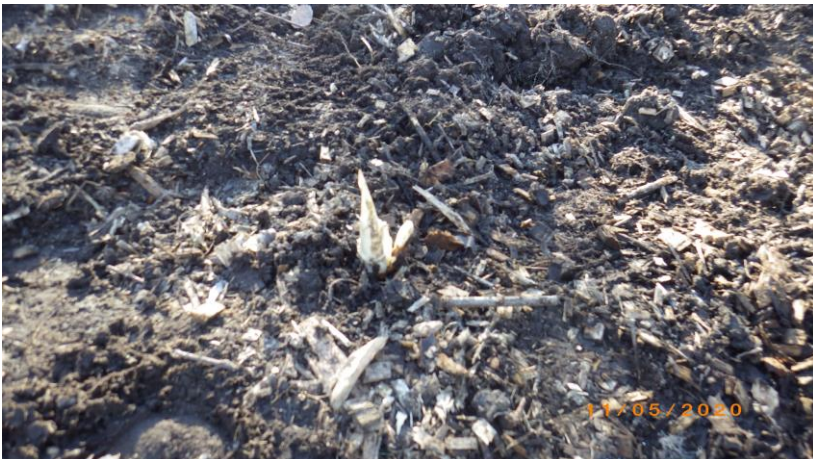
Skunk cabbage early growth

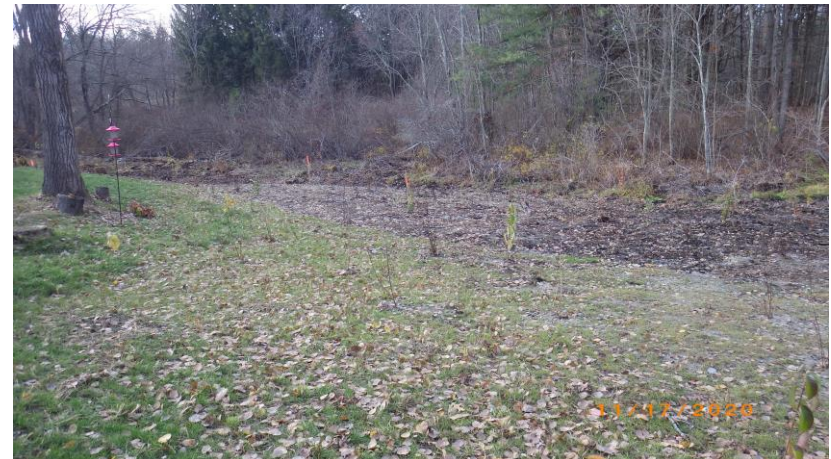
Central and western portion of restoration area after planting

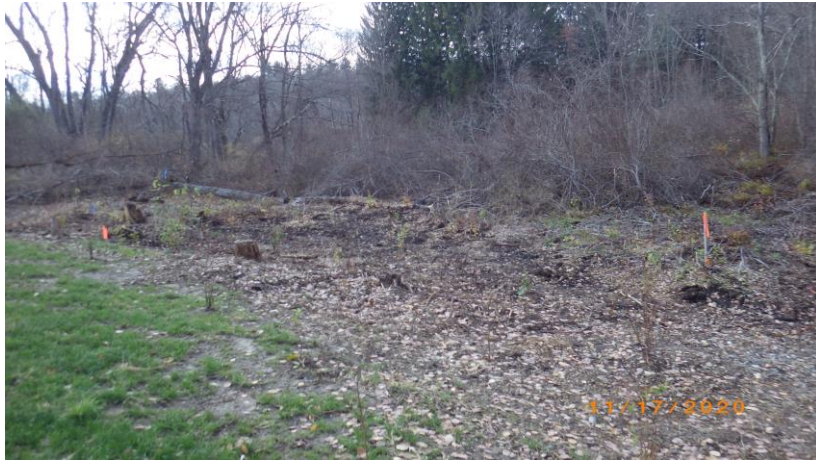
West end of restoration area after planting

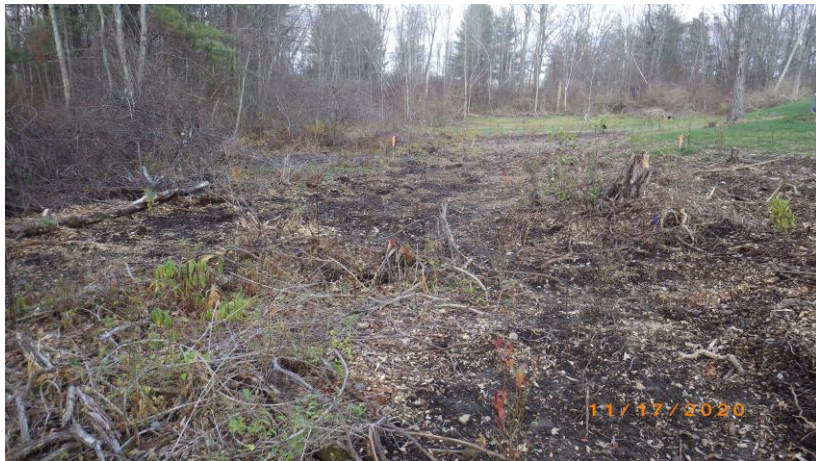
View east from west end of restoration area after planting
