# STORMWATER REPORT

**Lot 11A & Lot 9  
at 201 Hilltop Road  
(Map 32 Assessor Parcels 1J & 1K)  
Lancaster, Massachusetts**

**December 6, 2021**

Harrington Associates, LLC  
20 Main Street, Wedgewood Office Suite 3  
Acton, MA 01720  
Tele: (978) 989-1373  
Email: rjharrington4@gmail.com

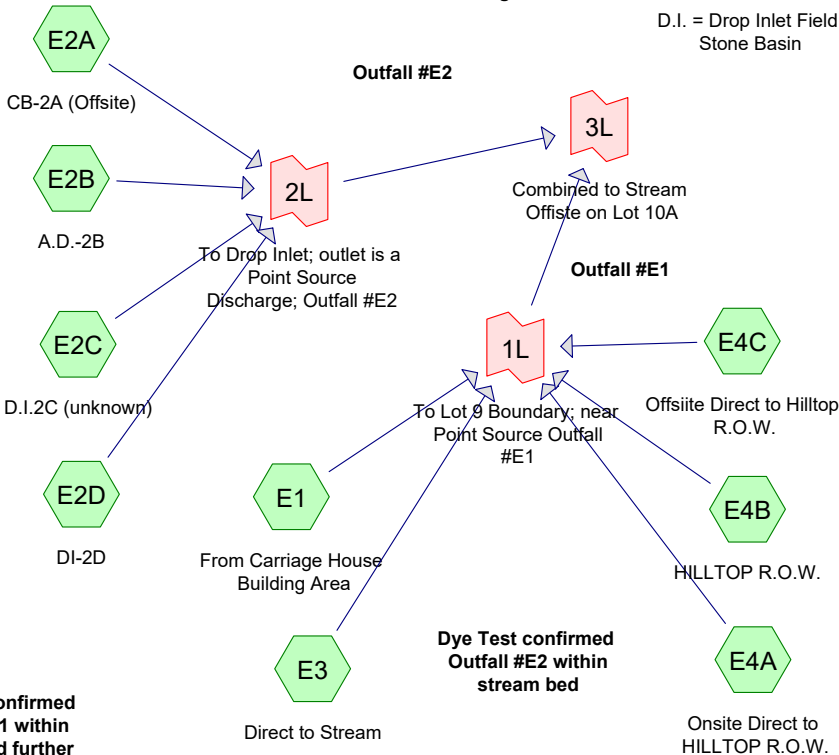
**Routing Diagram for Hilltop-Pre**

Runoff from within Public Street R.O.W. Above Carriage House Driveways down to end of Lot 9

Left-side of Carriage House sheet flow across street frontage into gutter

The selected Comparison Edge 3L represents combined flow from 1L and 2L.
