# WELCOME!

U.S. Army HQDA/ODCS G-9 Base Realignment and Closure (BRAC) Environmental Coordinator (BEC)

### 1 | RAB ACTIVITIES

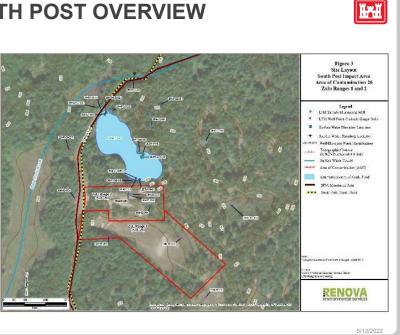
### AOC 26 – Zulu Ranges

- Semi-Annual Sampling
- May 4 Monitoring Wells & 5 Surface Water Sampling Locations
- November 11 Monitoring Wells & 5 Surface Water Sampling Locations
- At the kettle pond located adjacent to Zulu Ranges 1 and 2, water inflows consist of groundwater converging flow and precipitation (direct into the pond and runoff within pond watershed).
- Water outflows from this pond include groundwater diverging flow, evaporation, and surface water discharge through the culvert located at the northwestern end of the pond and below Firebreak Road to Slate Rock Brook.

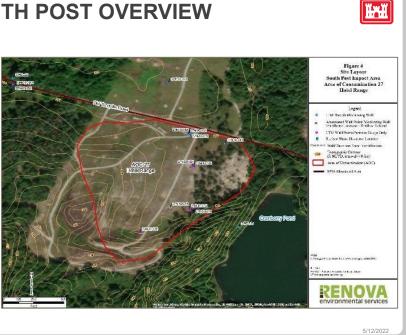
### AOC 27 - Hotel Range

- Biennial (every other year) Sampling of 4 monitoring wells in November [next November 2022]
- A proposed renovation to reorient the Hotel Range is currently in the permitting and construction contract solicitation phase
  - While most planned construction activities are slated to occur outside the SPIA Monitored Area, some tree clearing and site work (regrading) could take place within the area of AOC 27.
  - The current network of monitoring wells will not be impacted by the planned construction and reconfiguration.
