# ADAPTIVE REUSE & REHABILITATION PLAN

## The Prescott Building Lancaster, Massachusetts

January 2012

## EXISTING CONDITIONS & RECOMMENDATIONS

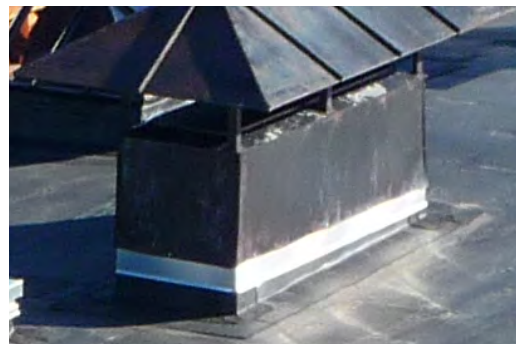
Flashing detail at ventilator.

- Maintain the existing roof in its present condition. Have the gutters cleaned at least once a year; plan on replacement with copper or galvanized steel.
- Plan to replace the corrugated metal downspouts with larger, round downspouts in a metal such as galvanized steel that will interact well with the existing aluminum gutters.

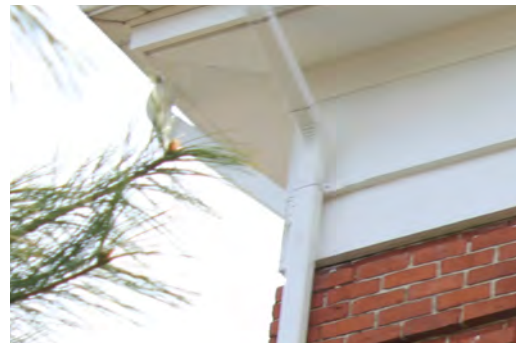
Two corrugated aluminum downspouts joining at northeast corner.

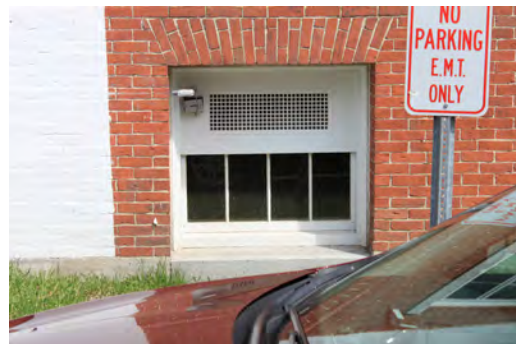
Basement window on south side of entrance.

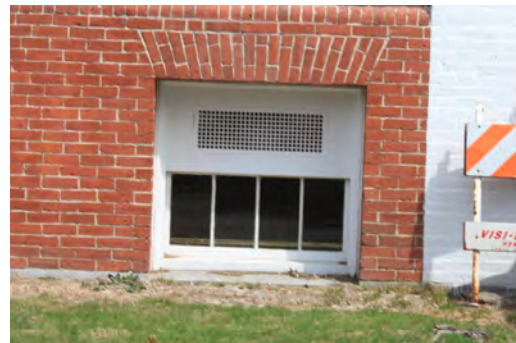
Basement window on north side of entrance.

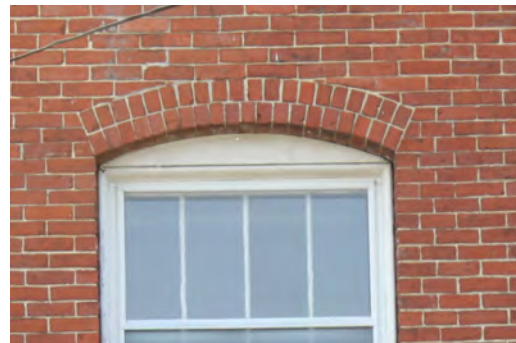
This facade is the only one which uses an arched lintel as opposed to a jack arch lintel.

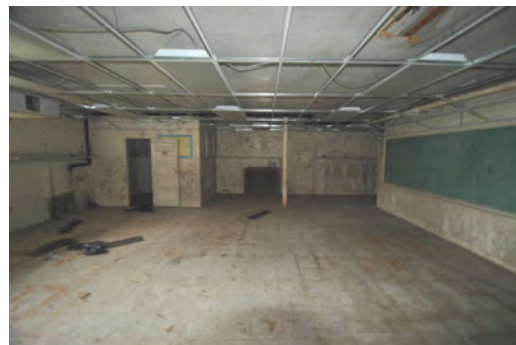
Former classroom in the basement level. Note dropped ceiling frame.

- Remove remaining dropped ceiling grids and lights. Install new ceiling.
- Scrape, prepare, and paint brick walls and wood wainscot.
- Abate asbestos tile and remove flooring to concrete slab.
- Install new mechanical, electrical, and fire protection systems.
- At minimum, install a dehumidification system for mold remediation.

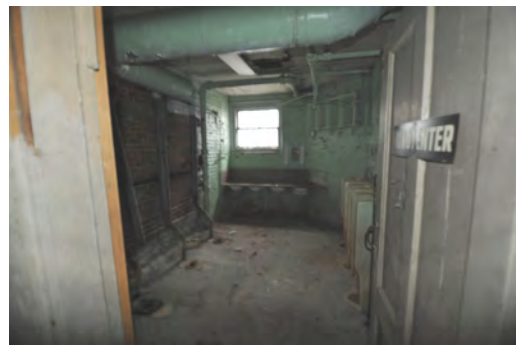
Mechanical room with asbestos laden piping and boilers.

- Repair and replace plaster ceiling as needed.
- Scrape, prepare, and paint brick walls.
- Abate asbestos tile in office.
- Install new mechanical, electrical, and fire protection systems.
- Remove and cap plumbing in rest rooms.
- Fill cracks and level existing concrete slab.

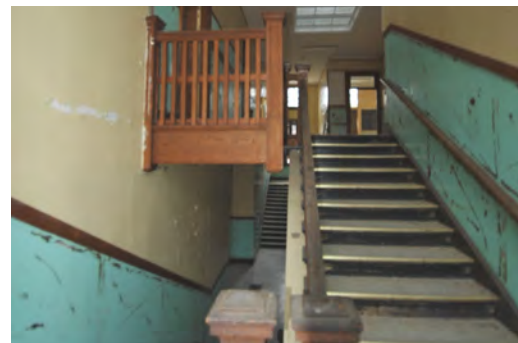
South staircase from first floor to second floor. Note the glue on the teal painted wall.

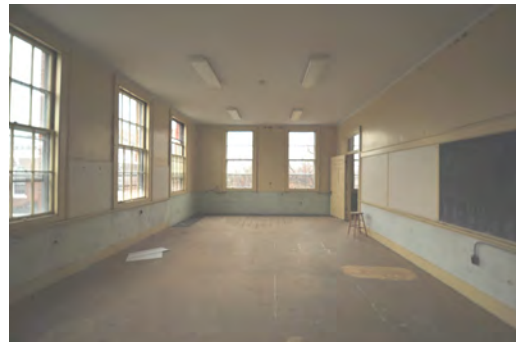
Classroom 3 on first floor, south east corner of building. This room has remnants of a tin ceiling, with acoustic panels glued to it.

- Restore plaster on walls and ceiling. Where necessary, remove plaster and replace with three coat plaster system.
- Remove tin and acoustic ceiling from Classroom 3 and install a new gypsum ceiling.
- Abate asbestos tile from the floors. If possible, restore the wood strip floor. Otherwise install new flooring suitable to the use of the room, e.g. carpet for the offices.
- Install new mechanical, electrical, and fire protection systems.
- Refurbish the existing built in cabinets for re-purposing in the buildings new use.

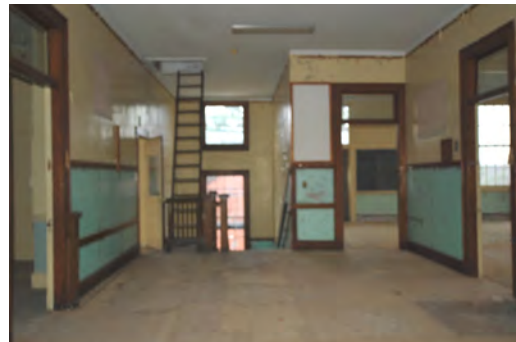
The plaster walls and ceilings are largely in good condition. A type of paneling glued to the plaster between the chair rail and baseboard has been removed, but the remnants of glue have damaged the plaster. The trim in these spaces is mostly intact. The floor has several layers of additional flooring added to the original wood floor, some of which contains asbestos.

Second floor hall with damaged wainscot paneling.

- Repair plaster ceiling and walls as needed. Replace plaster beneath chair rail.
- Clean and refinish all clear-finished trim.
- Abate asbestos tile from the floor.
- Install new mechanical, electrical, and fire protection systems.
